Broad Town White Horse

Garry Gibbons
July 2025

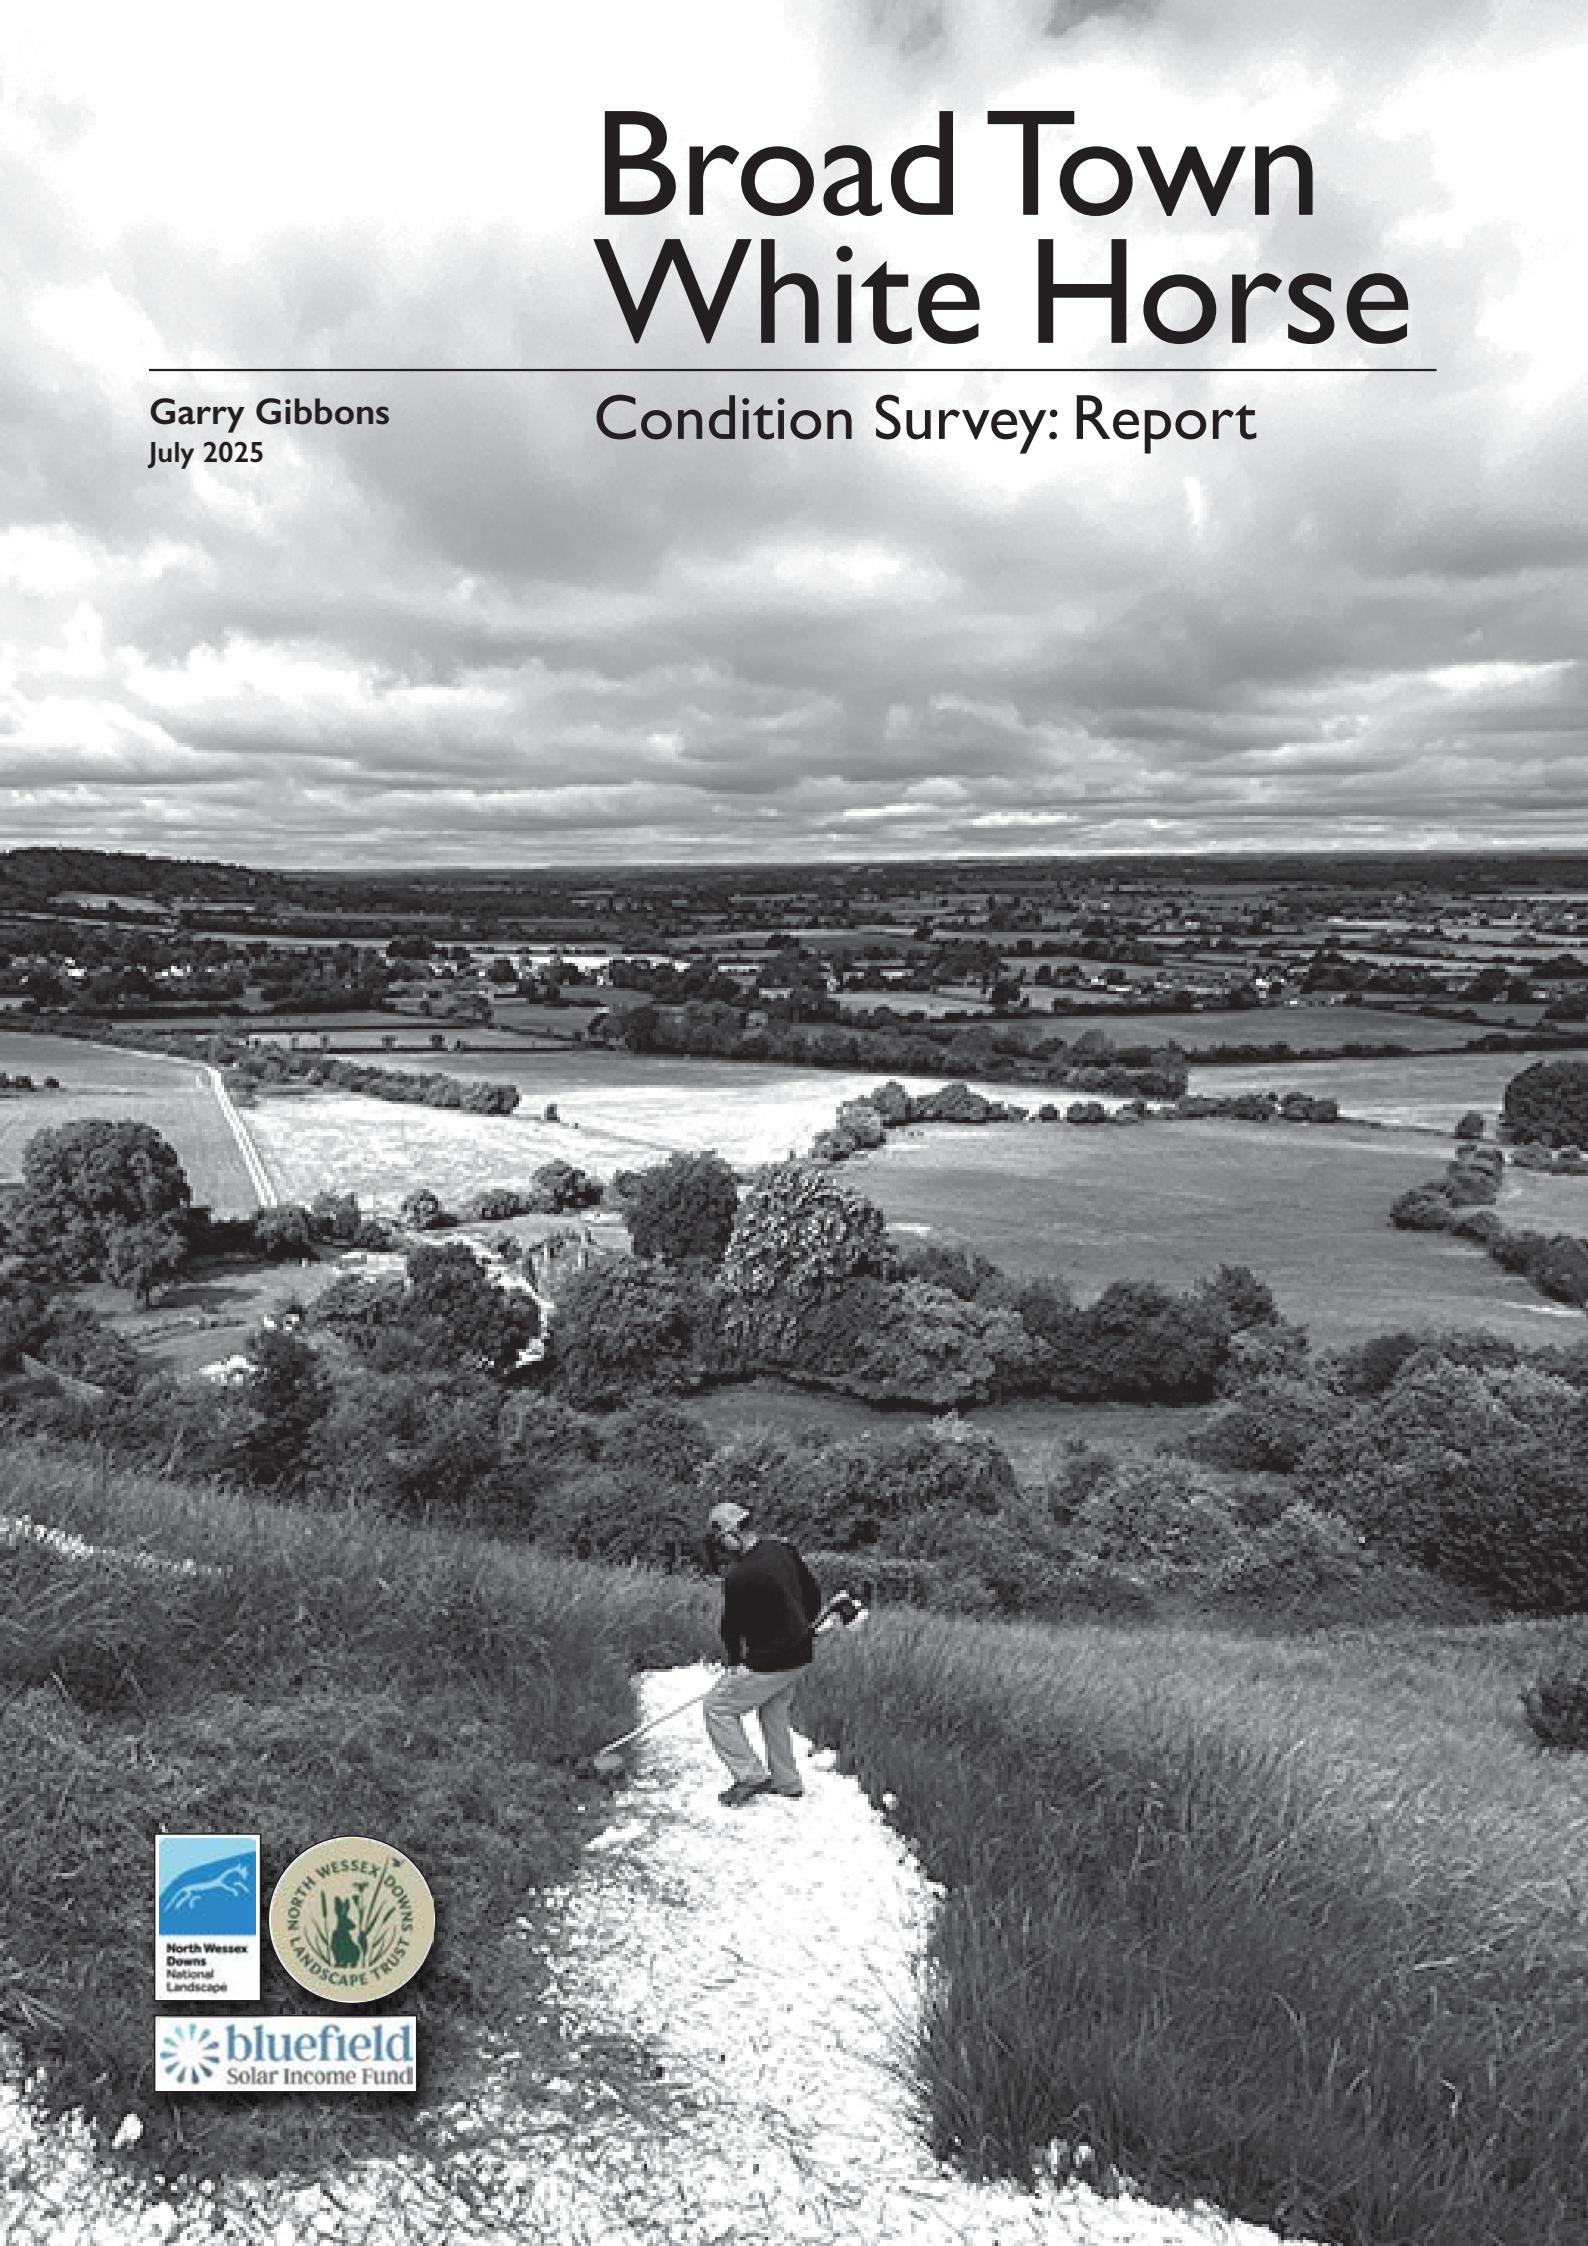
Broad Town White Horse

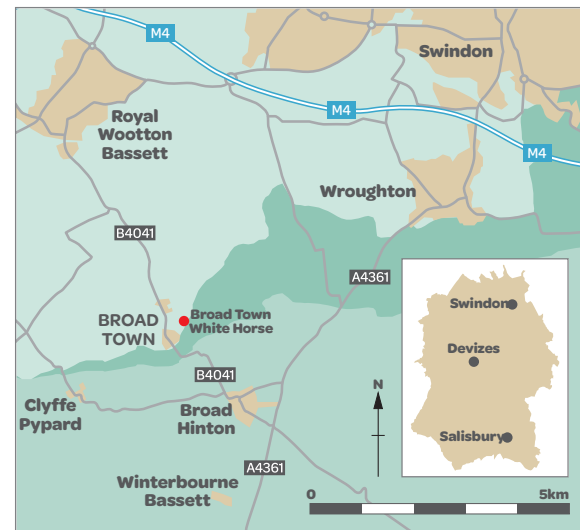
- record the general condition of the monument;
- evaluate the nature and level of risk to the monument;
- provide management recommendations to mitigate current levels of risk;
- highlight the role of community action in future management and mitigation work.

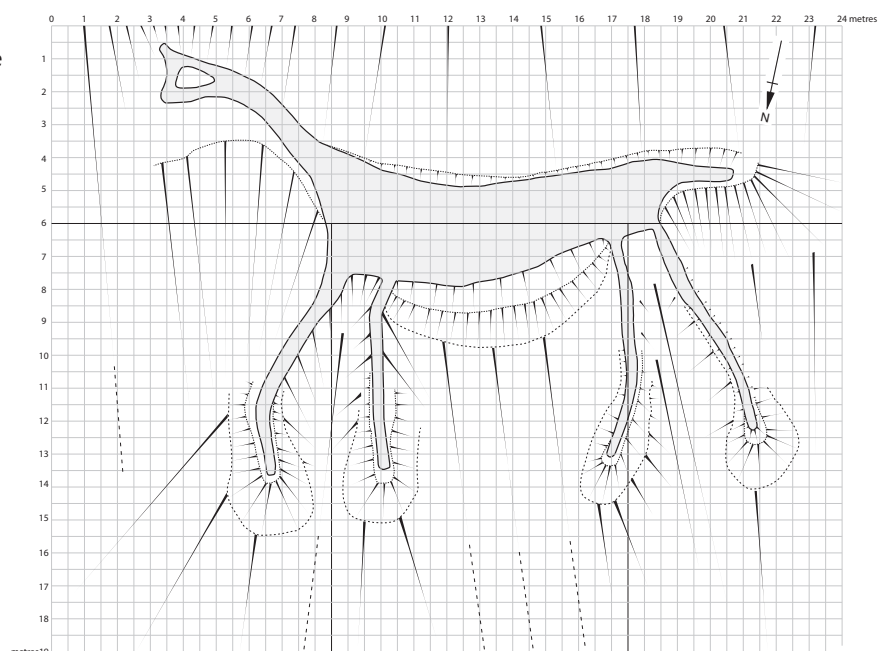
4.4 For the purpose of tracking changes to a hill-figure, recording ramps by survey can be highly informative (Ainsworth & Horgan 2013; Gibbons 2017; Gibbons 2021). Ramps also provide a degree of stability by effectively anchoring the hill-figure against the downward creep of the slope. Remodelling work carried out at the Broad Town horse to create a 'new' outline was established by digging out the existing ramps -- this resulted in new vertical revetments. To stabilise the new revetments, stakes and chicken wire were employed around the outline of the horse to prevent material falling from the face of the new revetments due to erosion and a tendency for downward creep (Fig 3).

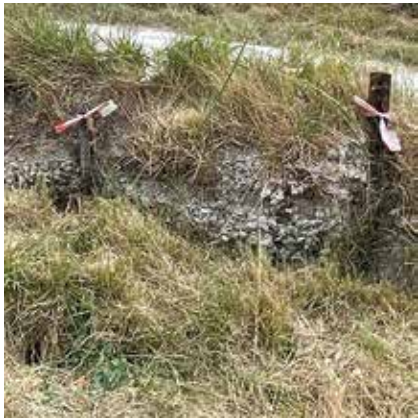
Fig 3: Face of 'new' revetment.

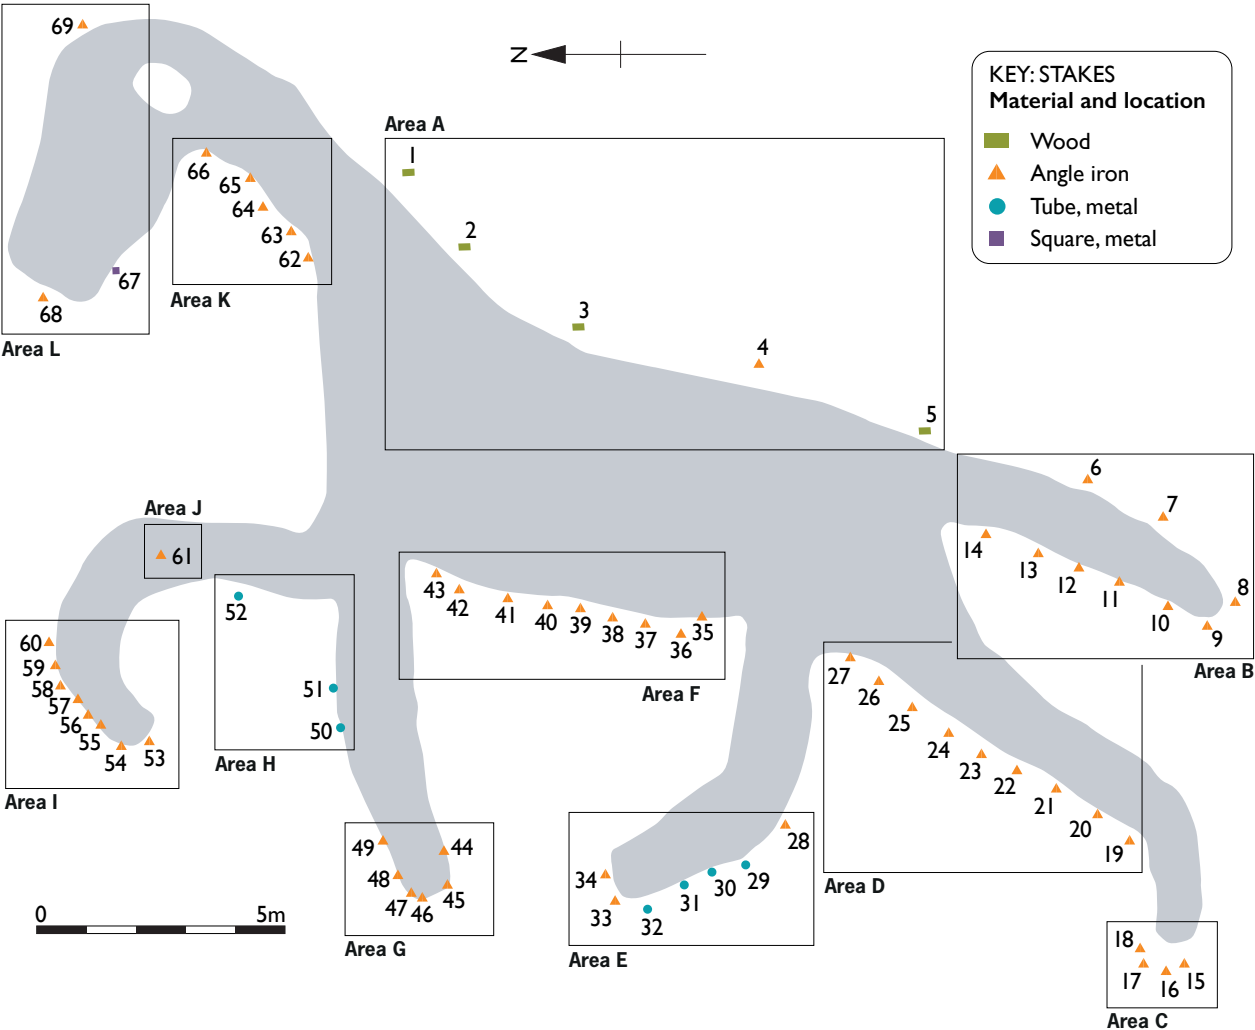
5 Broad Town White Horse Condition Survey: Areas A-L

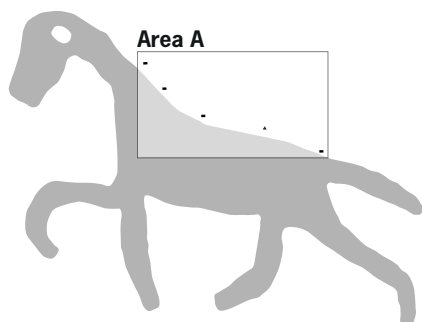
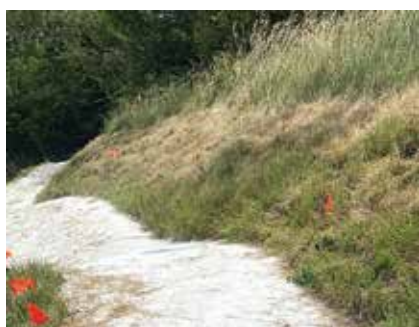
Fig 5: Area A, view along grass bank and back of horse, showing stakes 3-5.

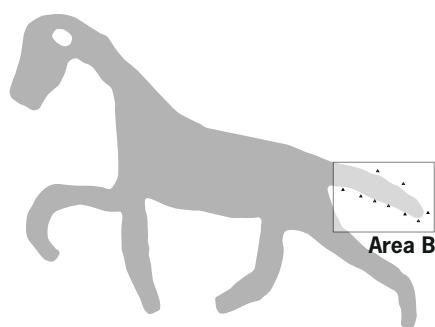
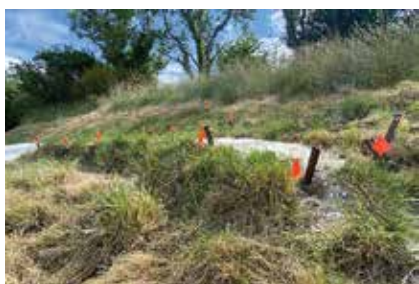
Fig 6: Area B, view along tail of horse, showing stakes 8-14.

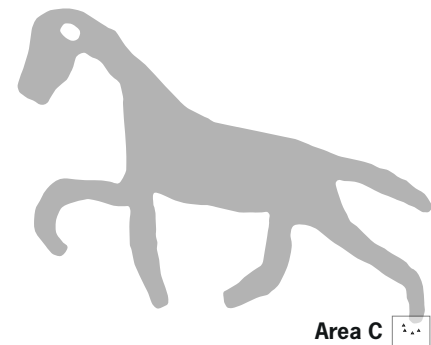
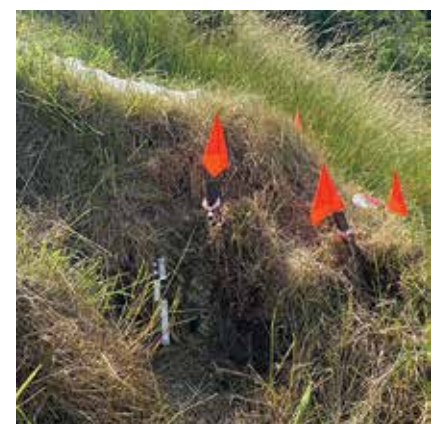
Fig 7: Area C, end of outside rear leg, showing stakes 17 and 18.

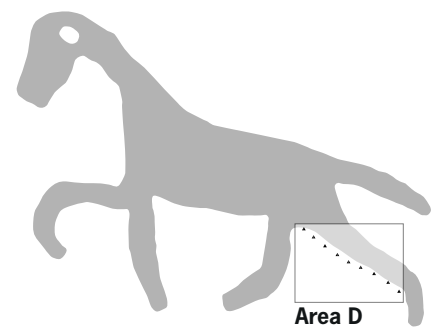
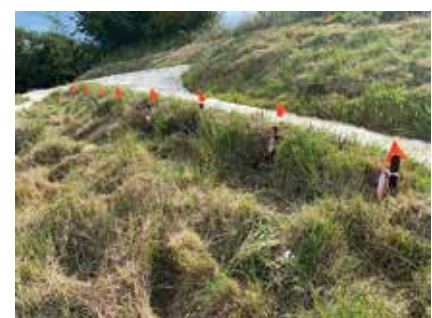
Fig 8: Area D, inner edge of outer rear leg, showing stakes 19-27.

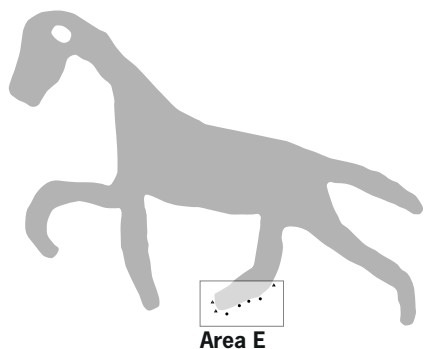
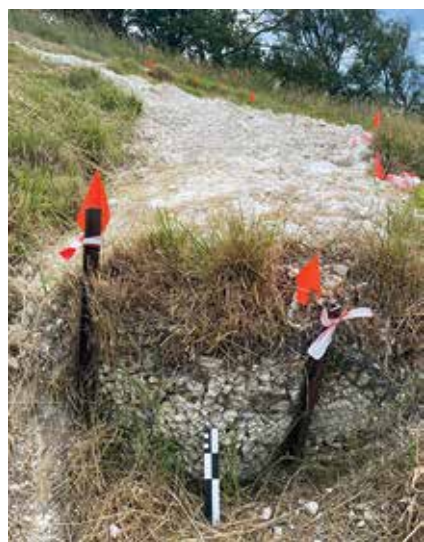
Fig 9: Area E, end of inner rear leg, showing stakes 33 and 34.

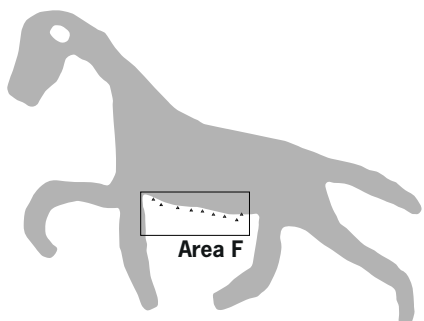
5.6 **Area F: Stakes 35-43**

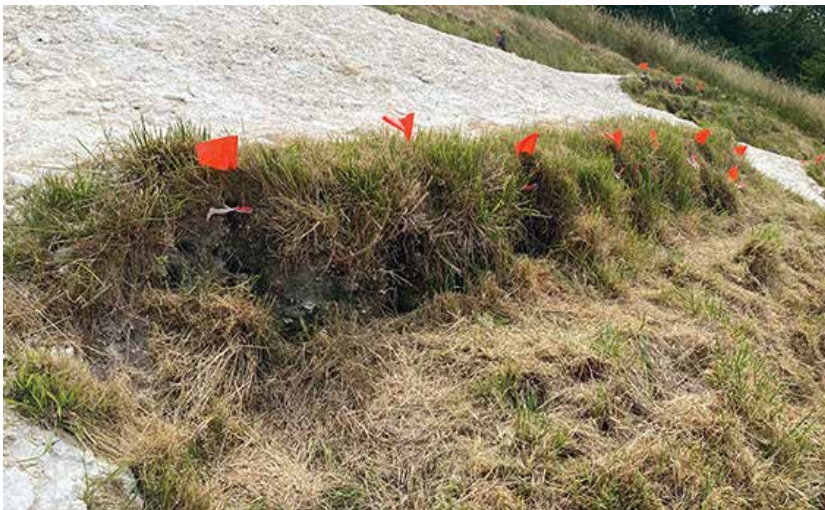
Short/medium term monitoring: systematically record and assess condition of revetment at regular intervals looking for signs of further erosion and collapse. Carry out close inspection of chicken wire along Area F.

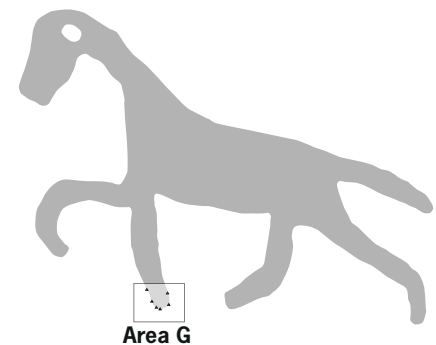
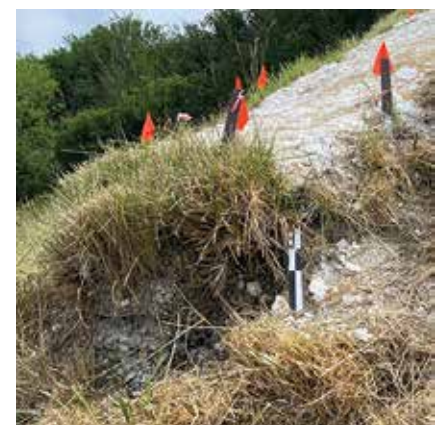
Chicken wire and stakes are gradually being engulfed by the downward creep of the revetment until their utility as a support will, ultimately, be compromised. Chicken wire is attached to the front edge of stakes 46, 47 and 48.

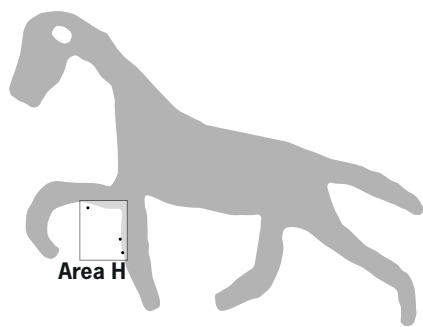
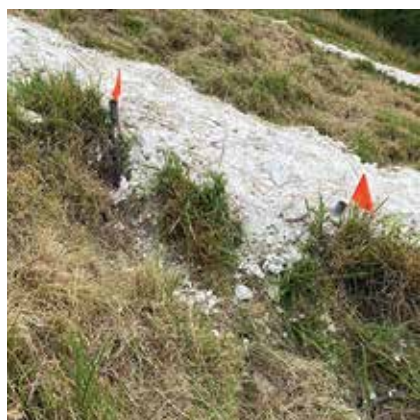
Fig 12: Area H, chest of horse, showing stakes 50 and 51.

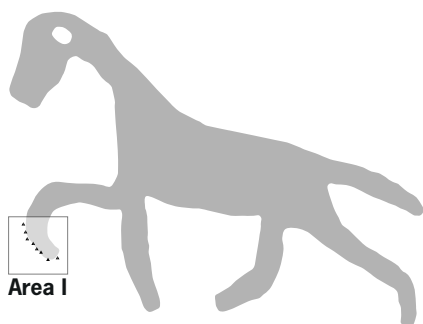
5.9 Area I: Stakes 53-60

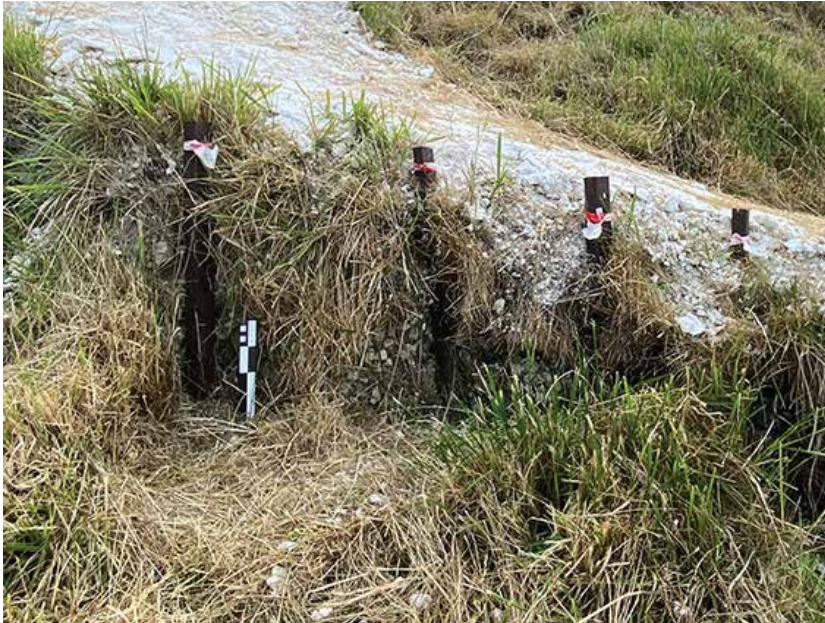
Regularly monitor levels of chalk and lime spillage, and revetment slumping at Stake 53.

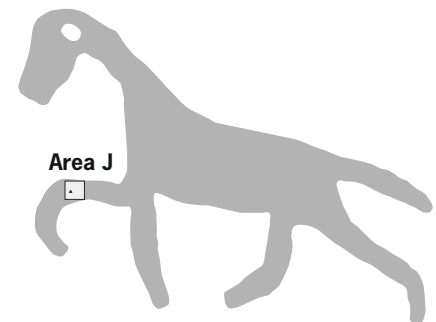
5.11 **Area K:** Stakes 62-66

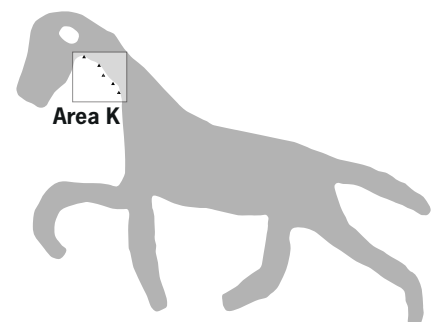
5.11.3 *Management issues*

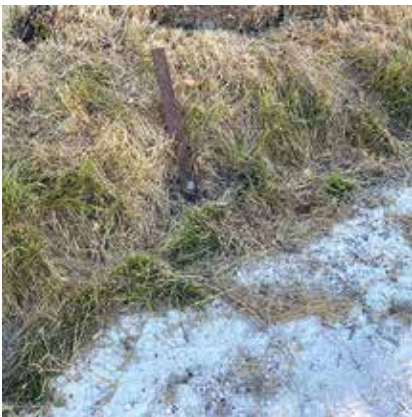
6 Vegetation and Animal Burrowing

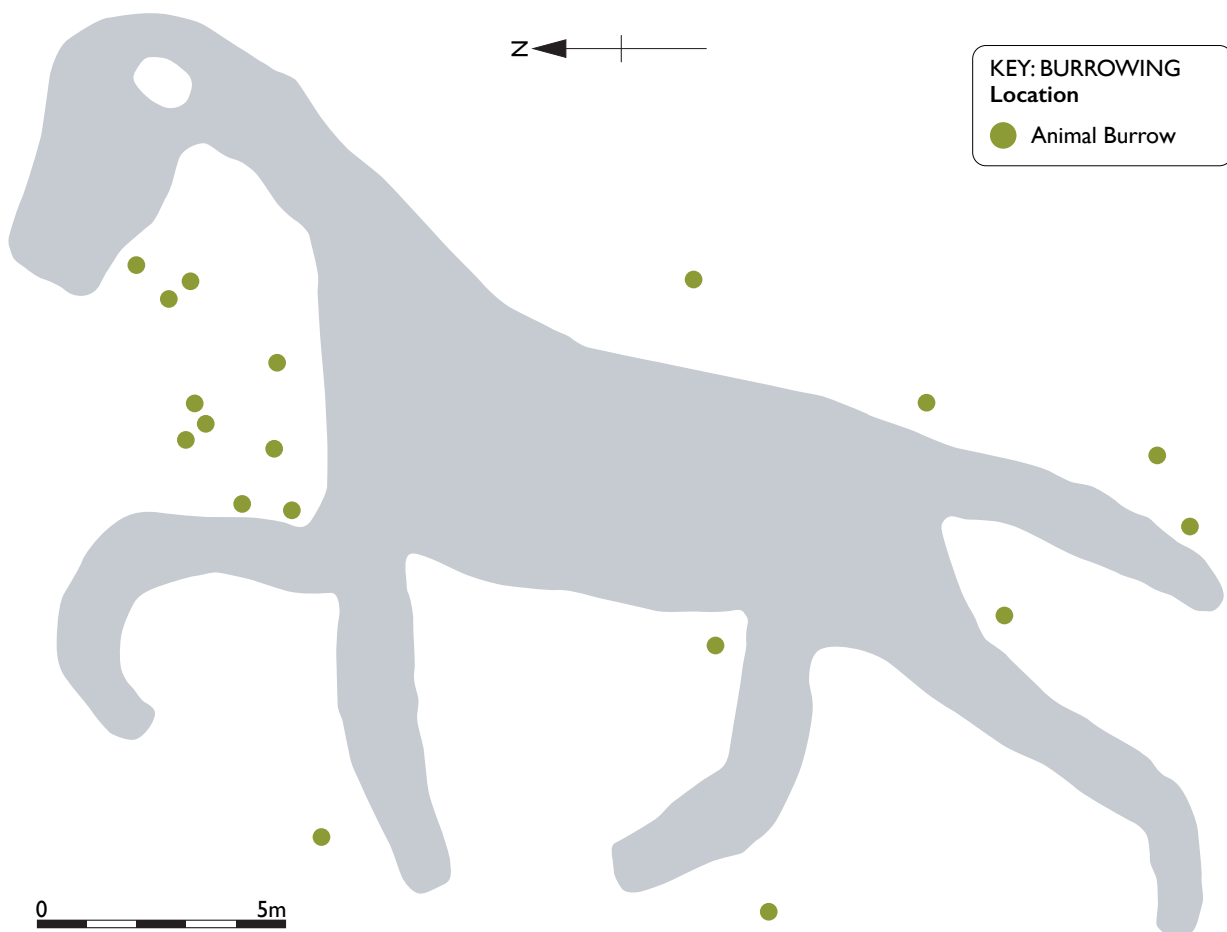
Fig 18: Burrowing activity

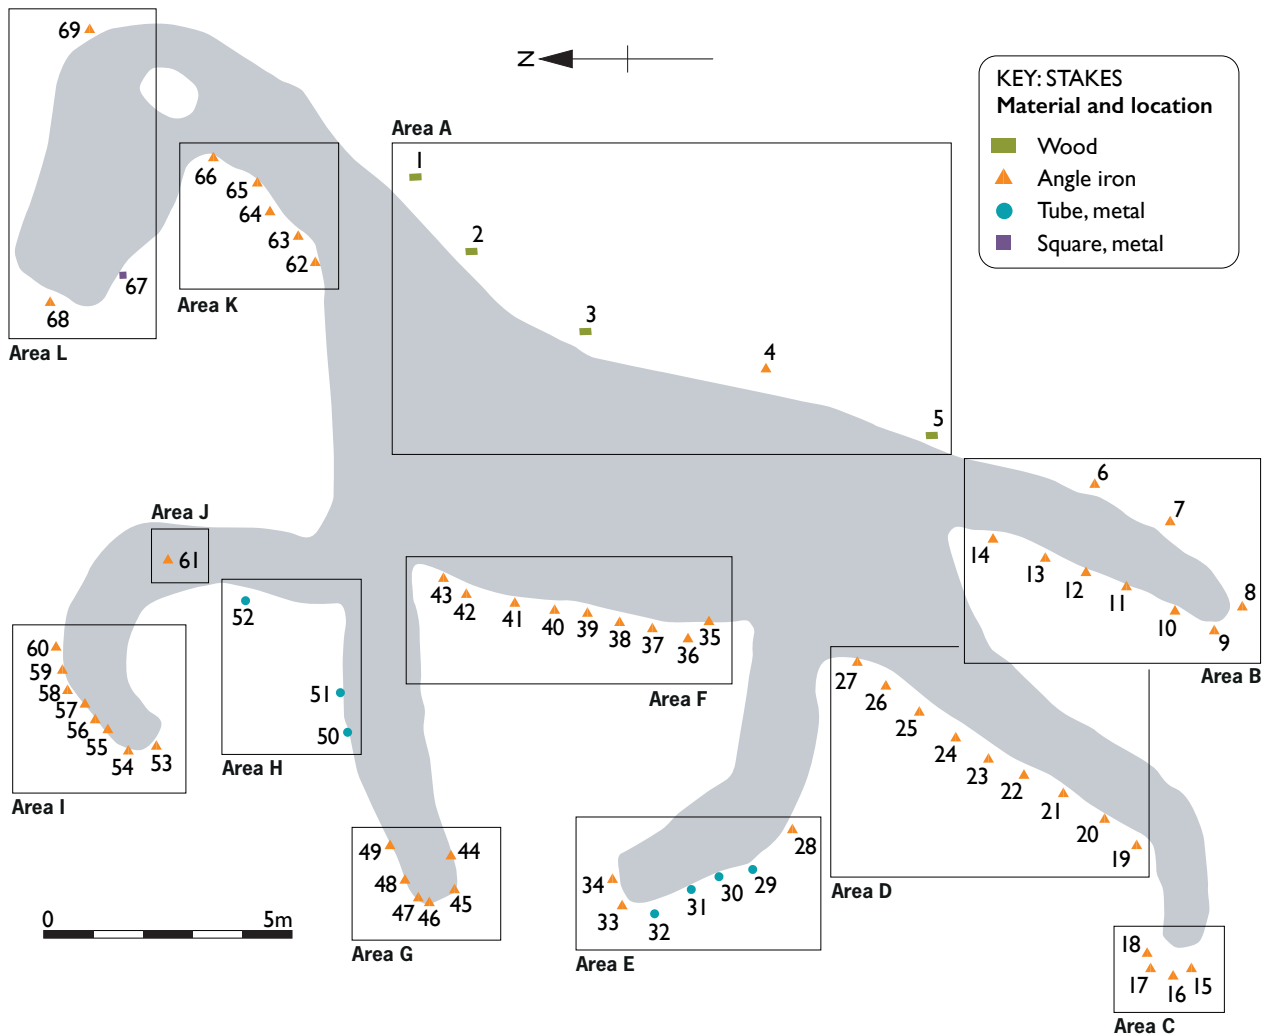
7.3 Volunteers completed Summary Record Forms (Appendix 1), recording each individual stake, including its size, condition, and its association with the hill-figure (see also Appendix 2: Glossary of Terms).

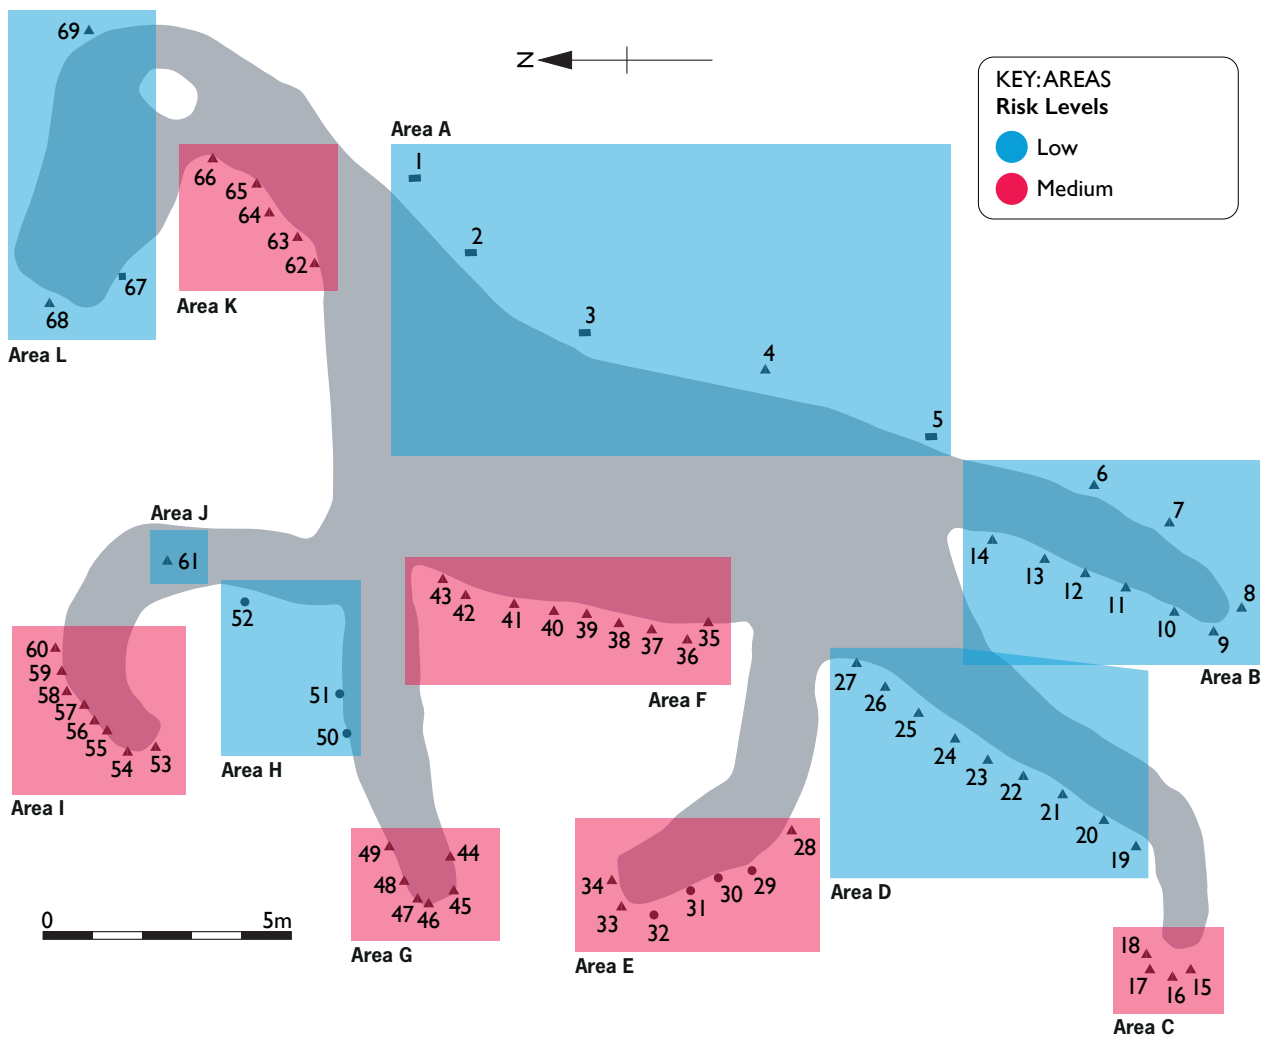
Fig 20: Levels of risk, Areas A-L

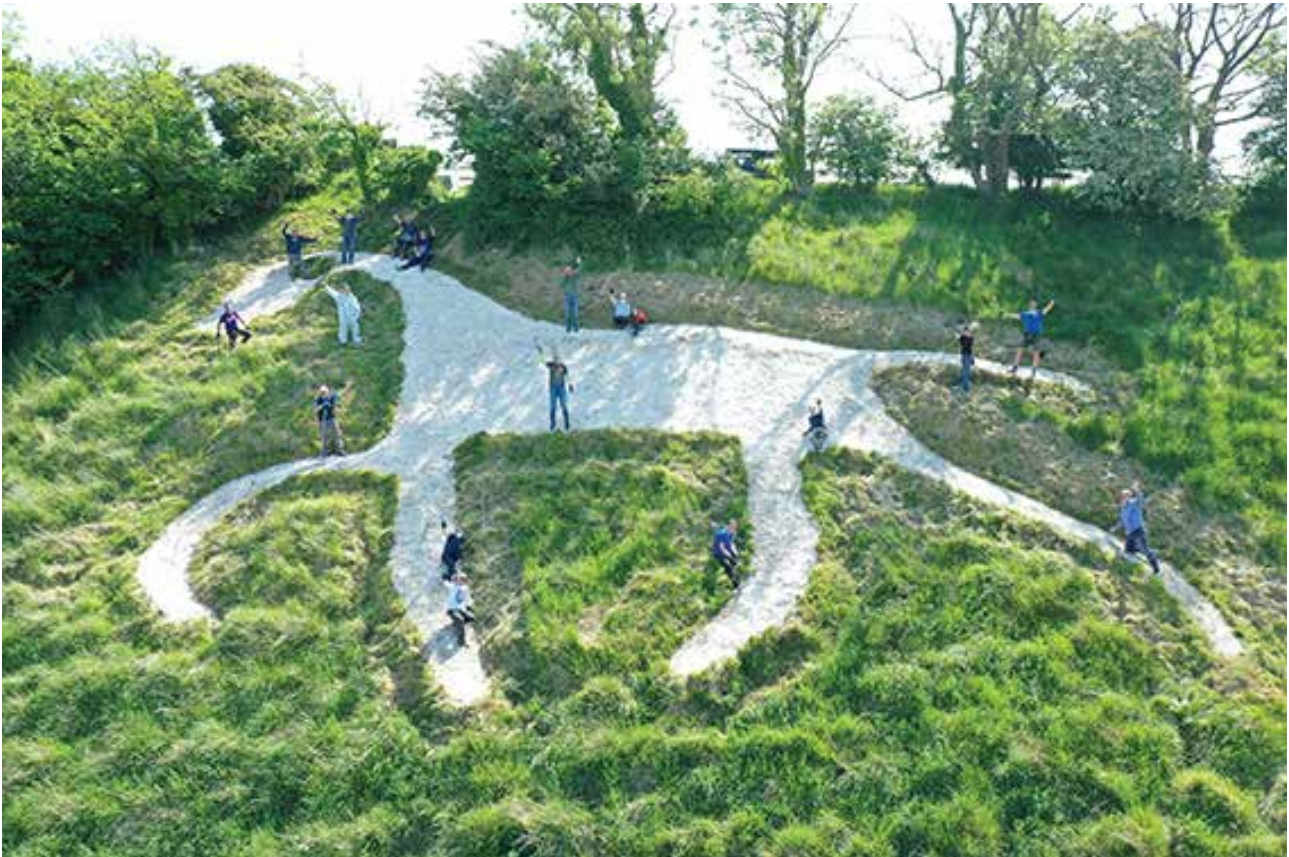
Fig 21: The Broad Town White Horse Restoration Group, 18 May 2025.

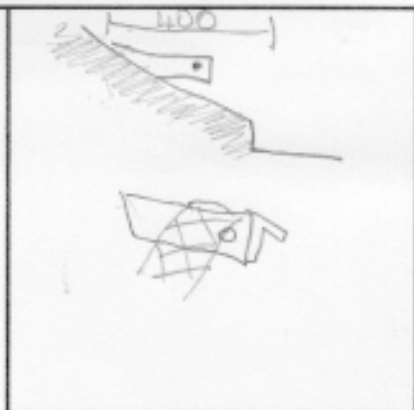
ANGLE IRON WITH PIERCED HOLE ($7\frac{1}{2}$ mm)
HORIZONTAL
CHICKENWIRE AT TOP 50mm OF STAKE

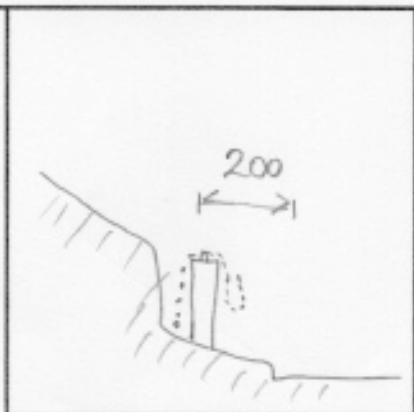
WOOD BROKEN BUT HELD IN POSITION BY
CHICKENWIRE.
CHICKENWIRE TO REAR AND WRAPPED OVER
TO FORM DOUBLE LAYER AT FRONT

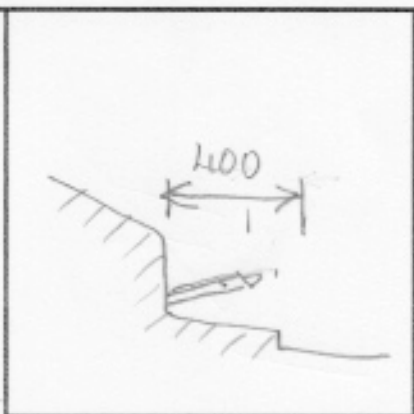
ANGLE IRON LYING HORIZONTAL.
NO CHICKENWIRE.
ANGLE IRON PIERCED 100mm FROM TOP
 $7\frac{1}{2}$ mm HOLE

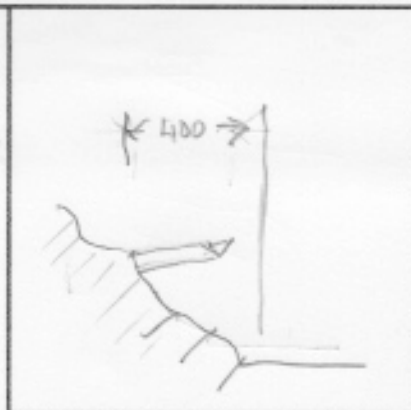
ANGLE IRON AT 30° TO HORIZONTAL UPWARDS
CHICKENWIRE IN BELOW STAKE BUT NOT
VISIBLY ATTACHED

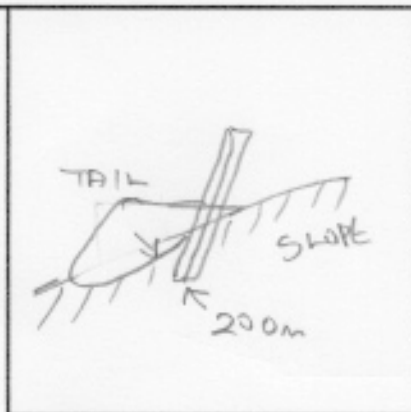
ANGLE IRON RUSTED BUT SOUND
 30° TO VERTICAL. TWO PIERCED HOLES
 $7\frac{1}{2}$ mm
NO CHICKENWIRE

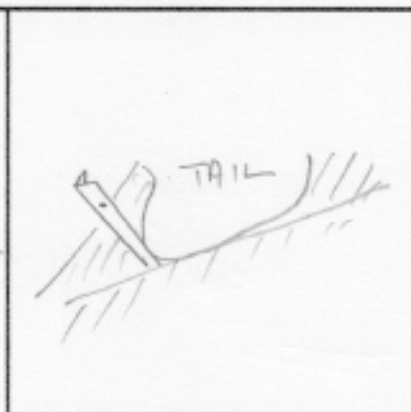
ANGLE IRON AT 20° TO VERTICAL
NO VISIBLE CHICKENWIRE
DIRECTLY ON LOWER SIDE OF END OF TAIL

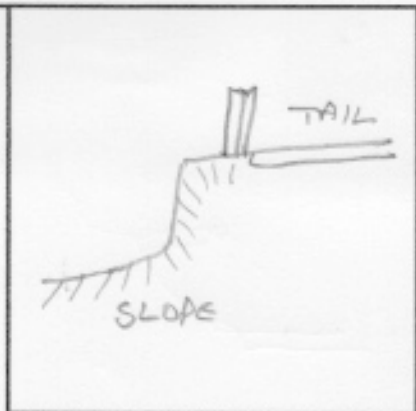
Active YES
SUPPORTING LOWER SIDE OF TAIL
DIRECTLY ON CHALK/SLOPE BOUNDARY

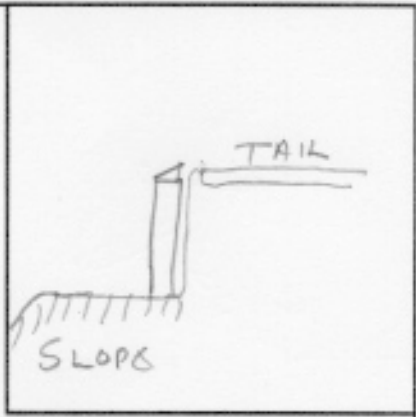
Active YES
SUPPORTING LOWER SIDE OF TAIL
POSITIONED DIRECTLY ON CHALK/SLOPE
BOUNDARY

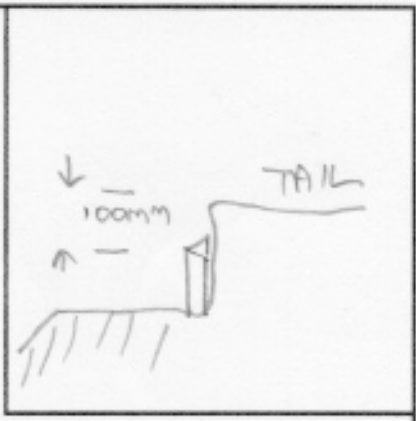
Active YES
SUPPORTING LOWER SIDE OF TAIL
POSITIONED DIRECTLY ON CHALK/SLOPE
BOUNDARY

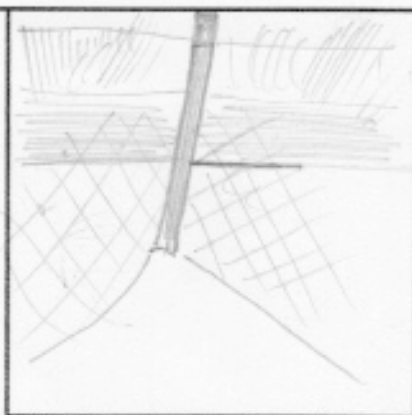
Rusted but solid, in place.
Chicken wire behind post

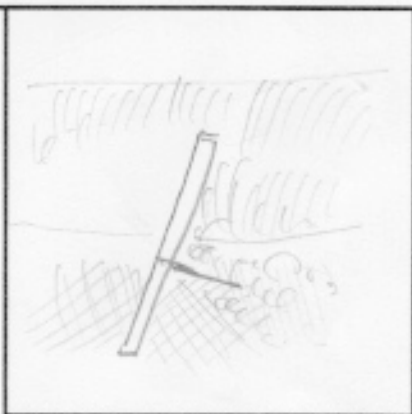
slightly rusted at bottom. Chicken wire slightly collapsing to right of post. No holes in post. Post at a large slant outwards.

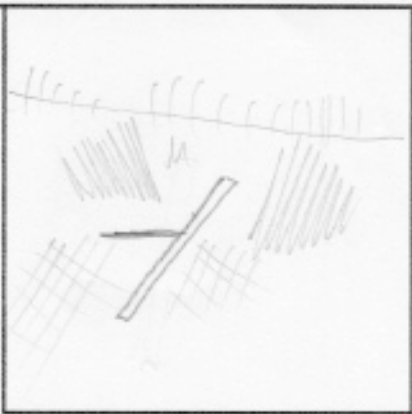
post rusted but otherwise doing good job. Chicken wire about half way up visible post. Chicken wire sagging both sides,

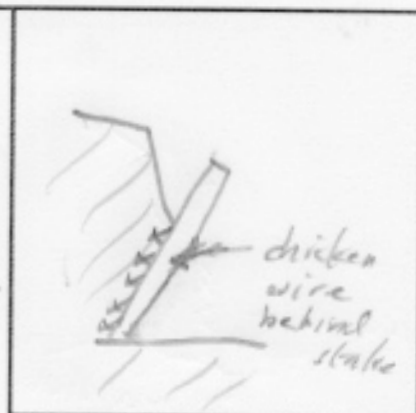
Will impact upper portion of leg if fails

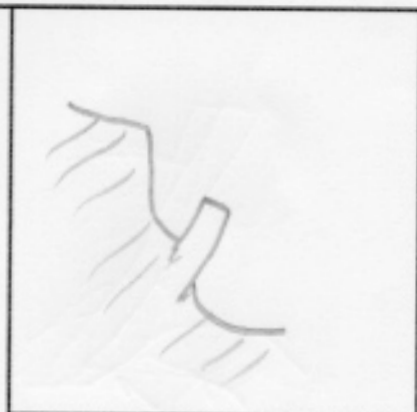
Localised slip of leg edge if fails
Chicken wire not visible

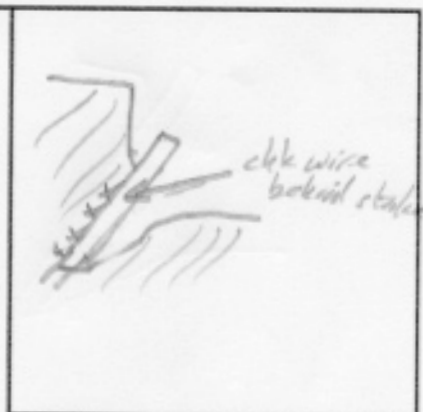
Upper corner of leg would collapse if removed

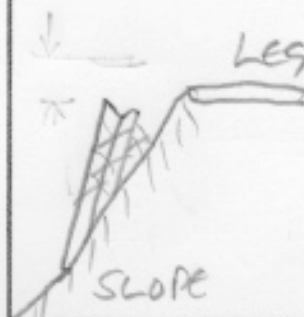
Active ^{SO} PRESUMABLY FIRST IN SEQUENCE
EFFECTIVELY ON CHALK SLOPE / BOUNDARY
SUPPORTING BANK ON LEG.

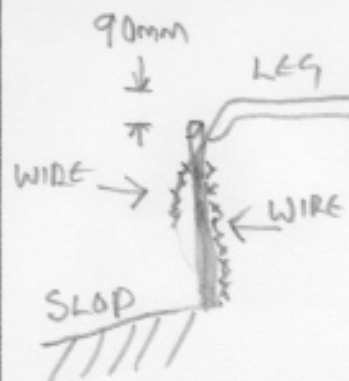
CHICKENWIRE IS SUPPORTING BANK / LEG

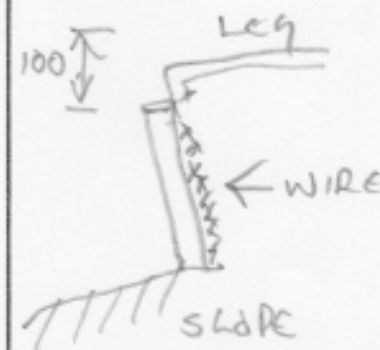
CHICKENWIRE IS SUPPORTING BANK / LEG

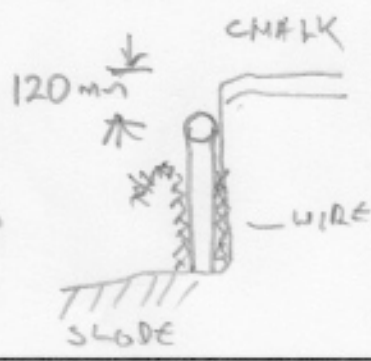
Active Y
SUPPORTS FOOT

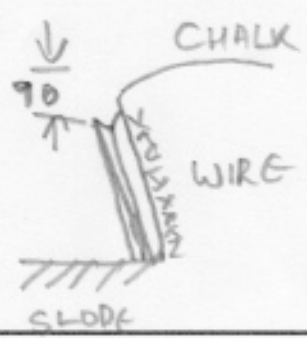
Active Y
SUPPORTS FOOT

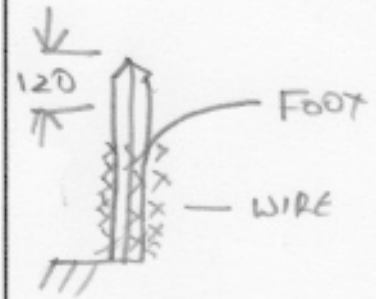
CHICKEN WIRE TO WITHIN 150 MM TOP.
WRAPPED ROUND STAKE AND SO END
OF SEQUENCE

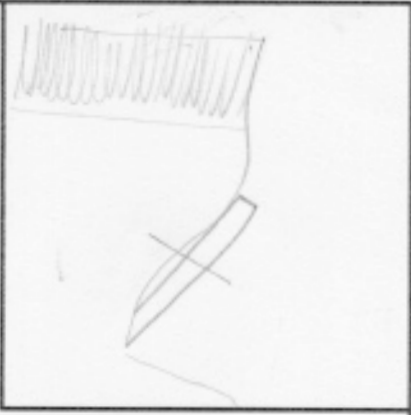
Active chicken wire to the right broken - slumping here especially, but generally clear the lead has slidden over time over the post.

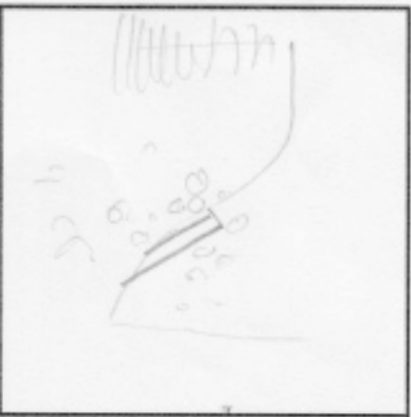
Active significant to support of horse but accumulated soil surrounding post.

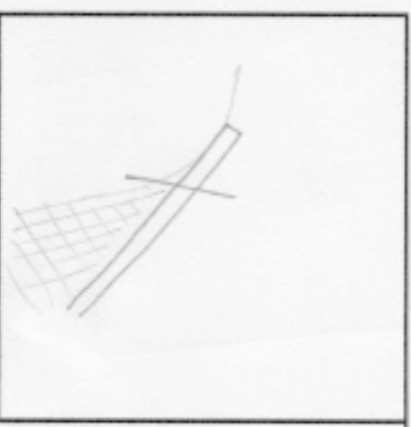
Active Yes. Holding up well. Chicken wire more supportive - contained bulging.

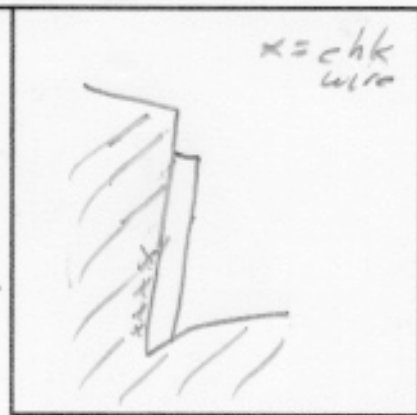
Angle iron, rusted, sound, firm in place

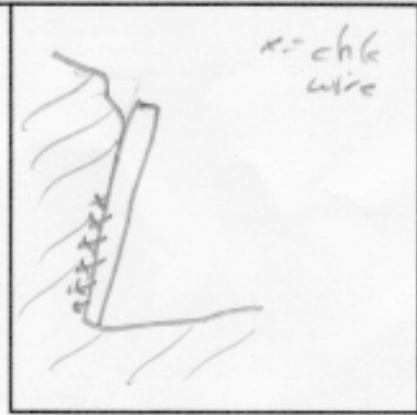
Angle iron, rusted, sound, firm in place

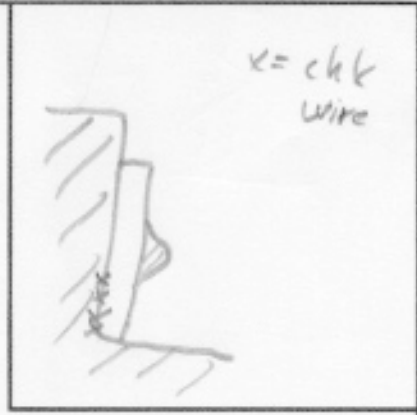
Angle iron, rusted, sound, firm in place

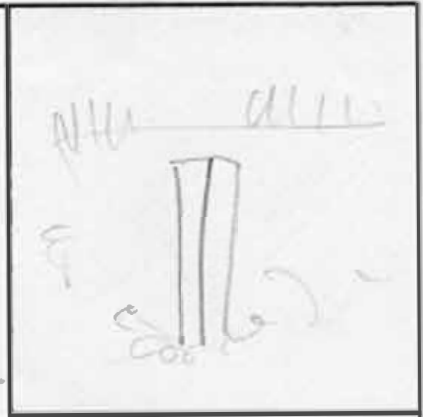
Active yes, supporting the corner between 2 back legs. chicken wire ~~is~~ ineffective and so slight overhang where the soil has slumped.

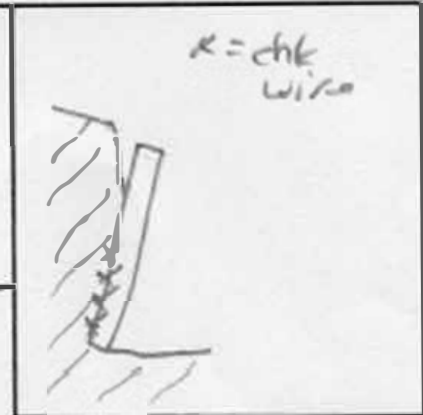
Angle iron, rusted, sound, firm in place

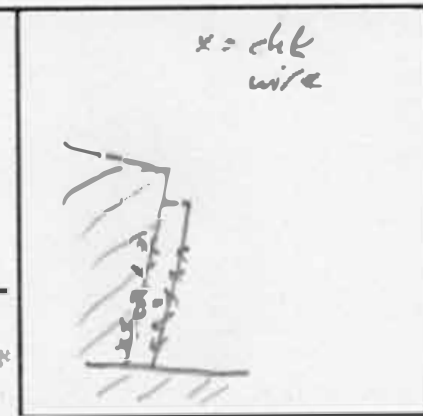
Angle iron, rusted, sound, firm in place

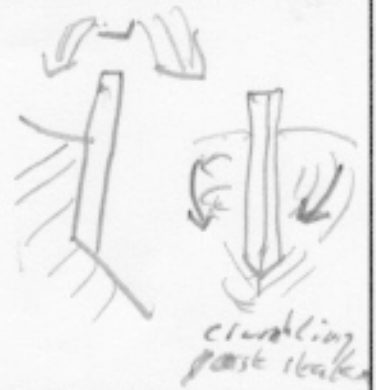
Angle iron, rusted, sound, firm in place

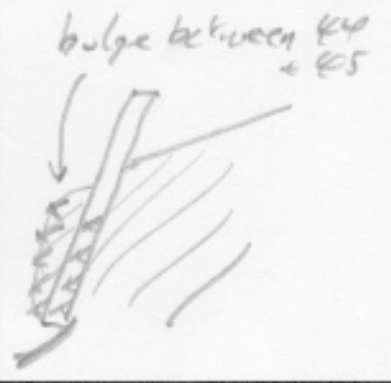
Angle iron, rusted, sound, firm in place

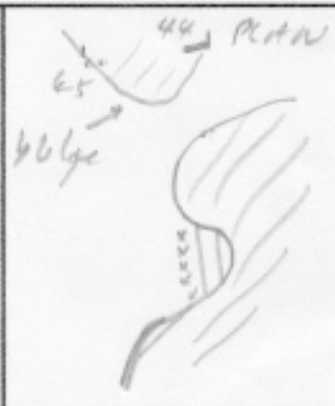
Angle iron, just visible as mostly buried.

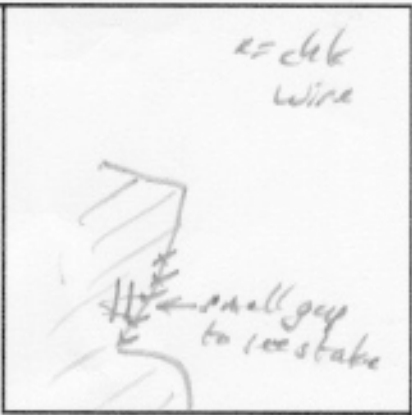
Active
Yes Active, Almost totally covered by chalk (inside wire) so not holding wire back

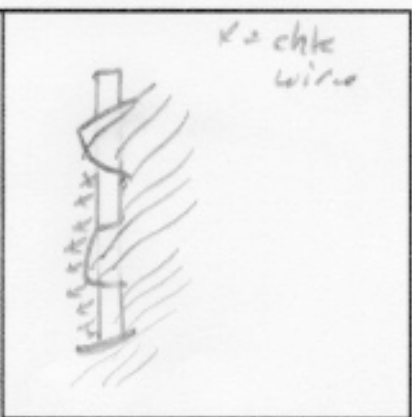
Active
Active restraining edge of "hoof" but inside chicken wire so not holding wire back

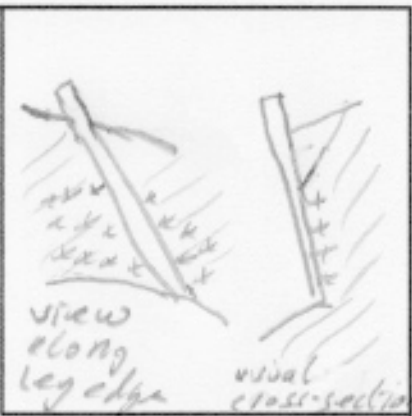
Active
Active at angle, On outside of chicken wire so holding wire in place

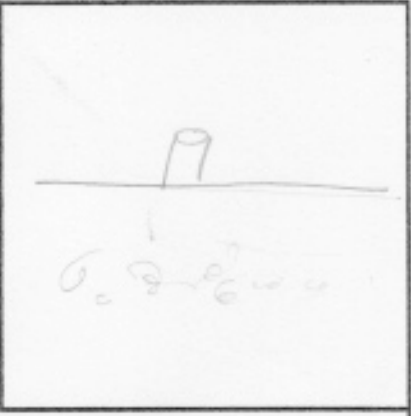
Impact ~~low~~ ^{medium} impact to leg. Already failing to the left of pole but not severe. Only local impact

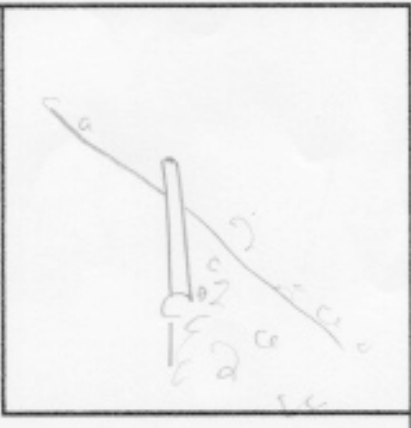
Impact stamping especially on lower side of post. Grass roots to the other side holding soil compact.

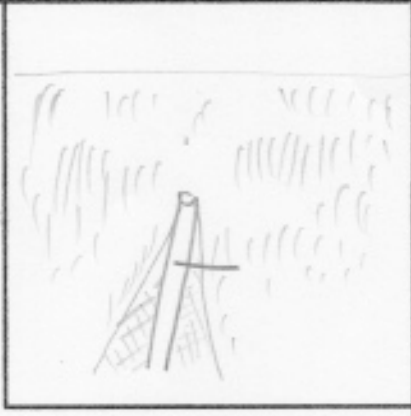
Impact medium to high impact to the local part of horse as only post supporting this stretch, but rest looks sound where roots are holding soil together.

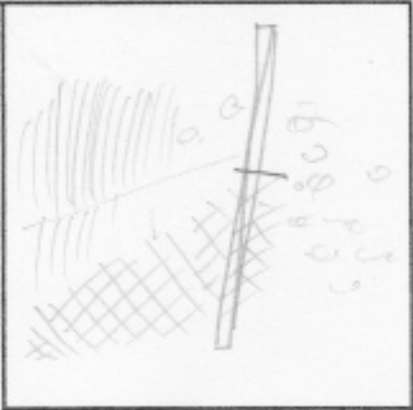
Active Active, mainly to the left where chicken wire holds. Lack of chicken wire on the right has caused some slumping of foot. roots to left above wire also providing protection.

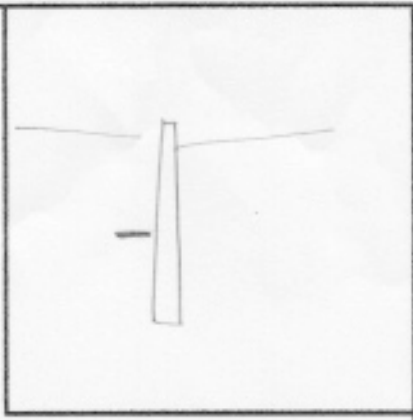
Active No significant bulges either side of post, roots in layer above wire. Holding well.

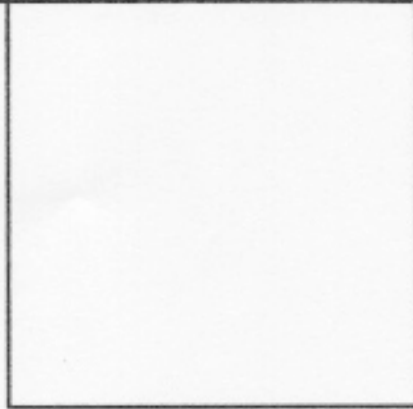
Condition of material, appearance, etc
