Broad Town White Horse

Garry Gibbons
July 2025

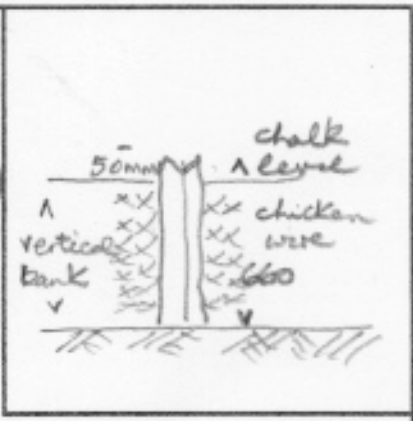
Condition of material, appearance, etc
Surface rust / sound / firmly embedded
chicken wire behind stake (holding chalk backfill)

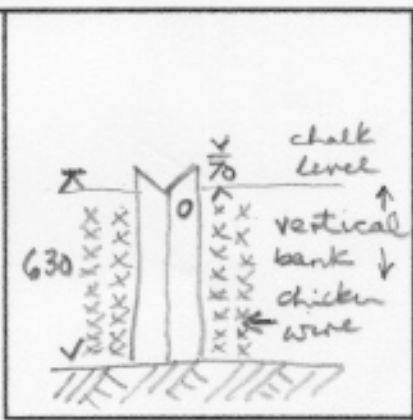
Condition of material, appearance, etc
Surface rust / sound / firmly embedded (slight movement) / chicken wire behind stake (holding chalk backfill)

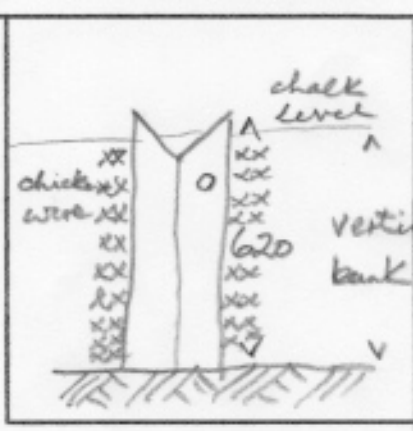
Condition of material, appearance, etc
Surface rust / sound / firmly embedded (holding chalk) / chicken wire behind stake (holding chalk backfill)

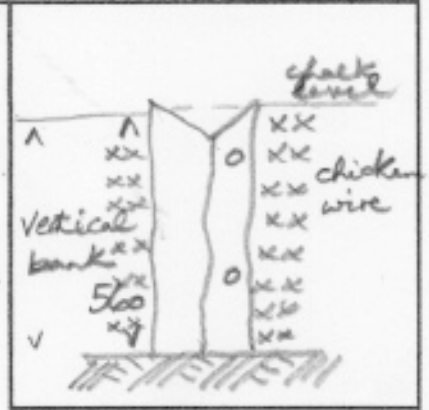
Impact
high - less likely to allow collapse of front (left) foot.

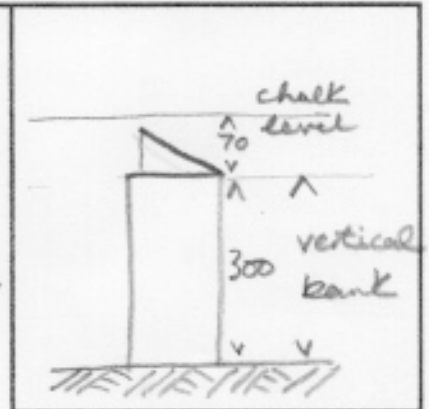
Impact
high - less likely to allow collapse of front (left) foot.

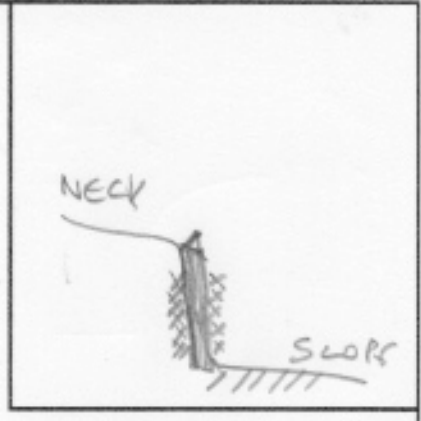
CORRODED BUT SOUND - NO HOLES
CHICKEN WIRE - FIRST IN SEQUENCE
CHICKEN WIRE STARTS 220 FROM TOP

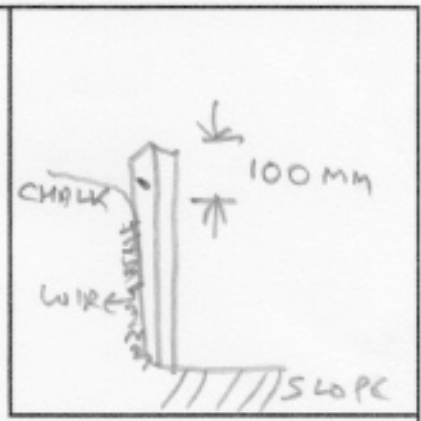
CHICKEN WIRE 200mm FROM TIP OF STAKE
PIERCED 11mm HOLE

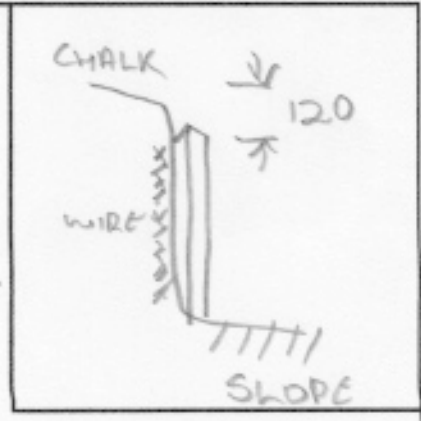
CHICKEN WIRE 150mm BELOW STAKE TIP
NO HOLES

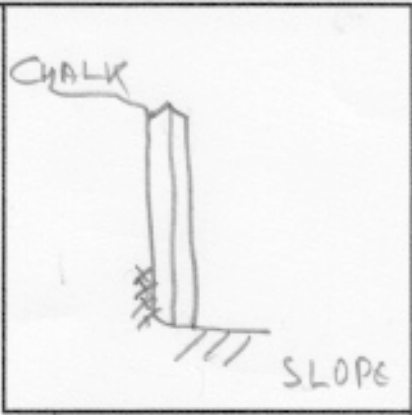
Active Y
SUPPORTS NECK. POSITIONED NECK / SLOPE

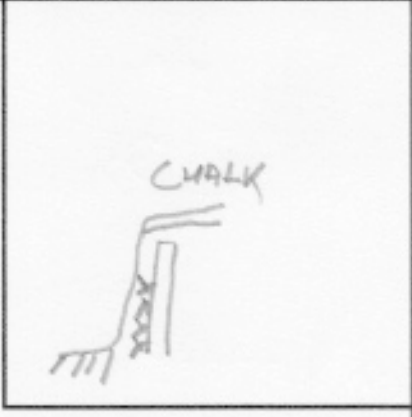
Active Y
SUPPORTS JUNCTION NECK / HEAD
ON EDGE AND UNDER CHALK

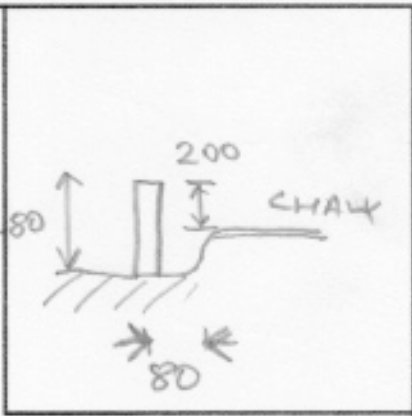
Active N
STAKE 80mm OUTSIDE JAW AND ON
LEVEL GROUND

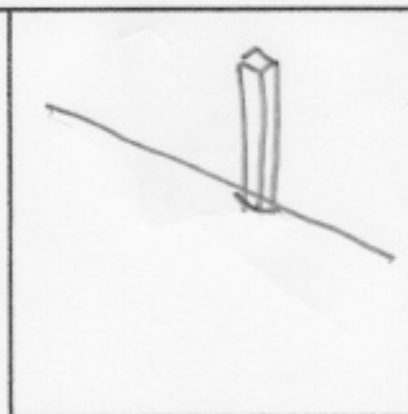
to edge of horse
no chicken wire

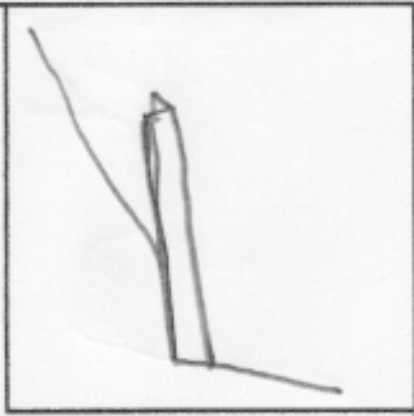
rusty, sound, slightly loose
