BROAD TOWN WHITEHORSE TOPOGRAPHIC ANALYSIS 2025 V2B

Broad Town White Horse Topographic Analysis

In response to a tasking received from the Broad Town White Horse Restoration Group (Andrew Law and Derek Greer project directors), fieldwork was undertaken at the Broad Town White Horse (BTWH) site, Broad Town, Wiltshire on the 28th June 2025. The site survey designed was twofold. First, to establish the exact position and condition of the current white horse and surrounding slope. Second, investigate the topography of the white horse for any evidence of its previous incarnations. To achieve both these aims, a detailed topographic analysis was undertaken of the horse itself with a lower resolution survey of the surrounding hillside to establish slope with GNSS (Global Navigation Satellite System) measurements. This data is supplemented with data gathered via UAV (Unmanned Aerial Vehicle) to be processed in Agisoft, Photoscan.

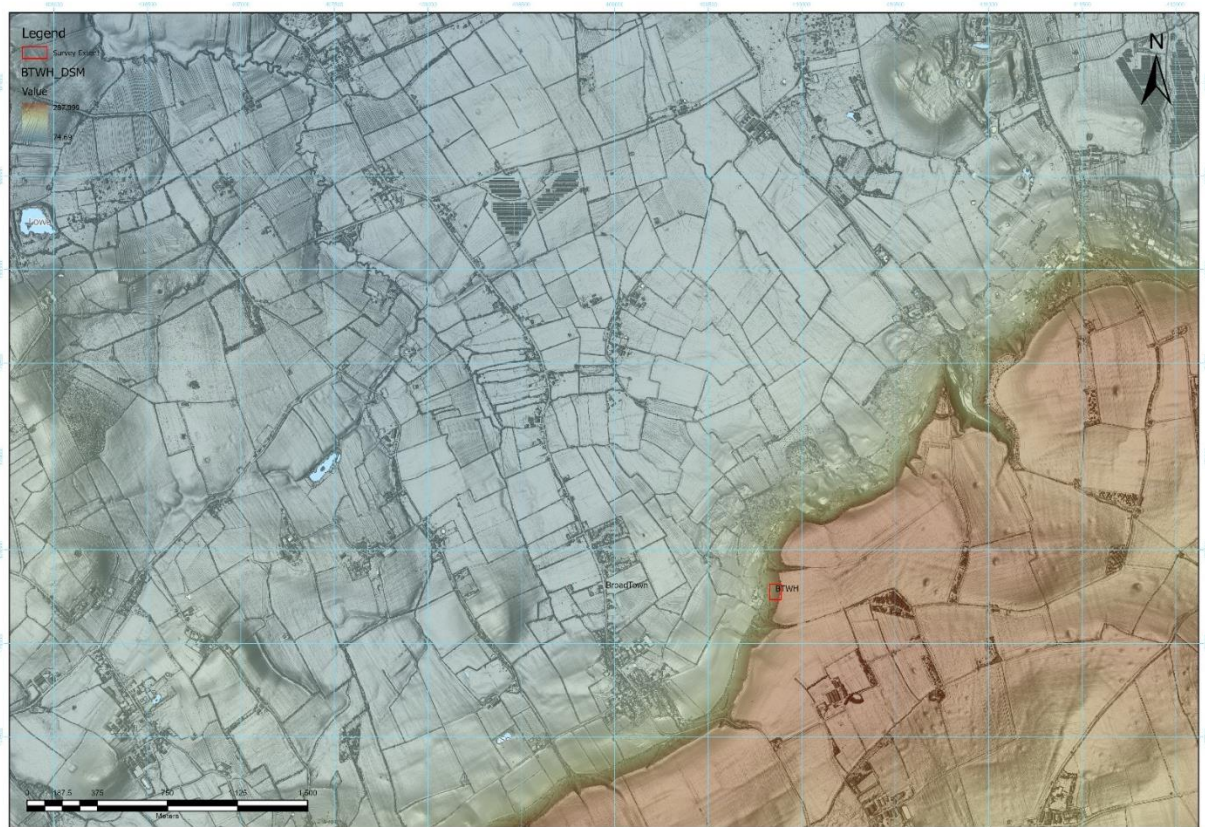
Figure 2: DSM Lidar surrounding BTWH (Approximate Location of analysed area Marked)

The Digital Surface Model was created from the same range of 4.5x5km as the DTM (E:405000 N:170000 - E:415000 N:185000), with a height range spanning 74.9-284.4mOD.

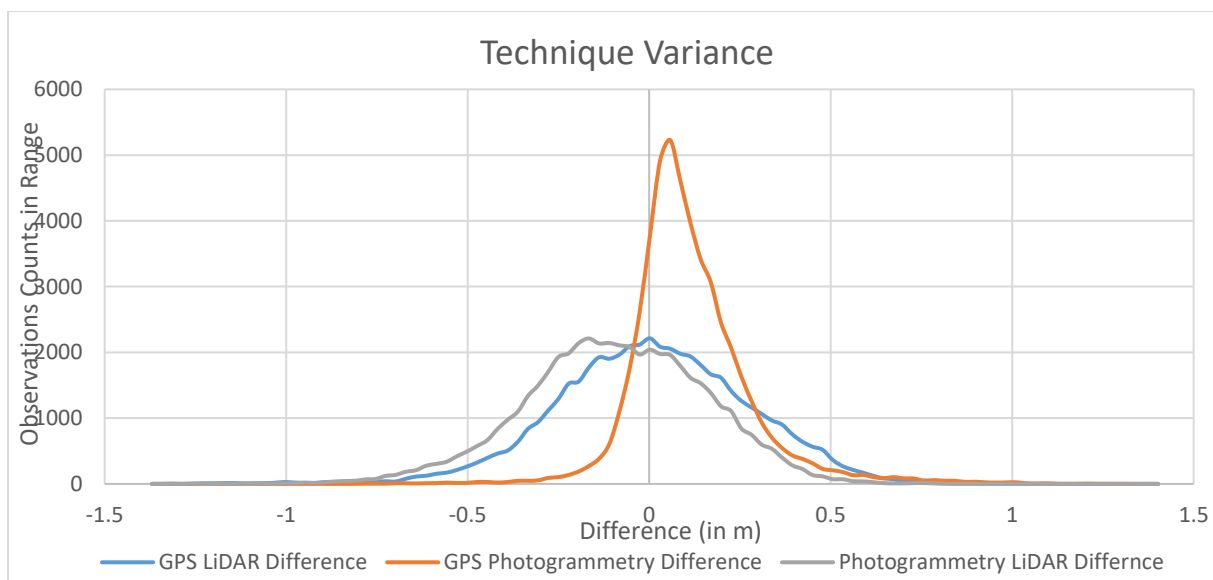
Figure 5: Variance of measurement techniques

Fig 5 demonstrates that although there is a greater difference in the mean, and range with the photogrammetry data compared the both the GNSS and LiDAR the variation is less. The UAV derived Photogrammetry averages a higher surface point as it records the vegetation but has the smallest Standard Deviation. The implication being that the photogrammetry derived is a close facsimile to the GNSS data, but available at much greater resolution. The conclusion being that although the photogrammetry data is recording a higher ‘untrue’ height compared to the GNSS points the patterns it is recording is the same as what we recorded with the GNSS at the resolution of 20cm.

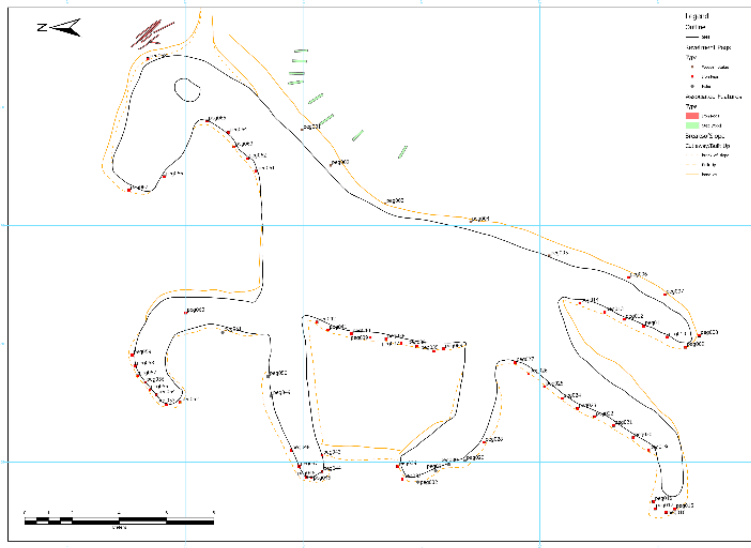
Figure 7: BTWH and Stakes and associated items

At the time of the survey 69 stakes were uncovered: 57 were angle irons, 7 poles, and 5 wood. The wooden stakes exist solely along the cut into the hill that produces the back and tail. The poles are along the front and mid rear leg. Oddly there is a single angle iron (no.60) placed within the chalk of the front leg for no apparent reason. The difference in material may mark different points in time of repair or consolidation. The poles (29-32, 49-51) seem to be placed beyond the obvious points of necessary revetments, implying use at a

different date to mitigate slippage etc. The wooden stakes are placed along the cut into the hillside and not at the points of build-up. Here it would seem necessary to use revetment as there was no possibility of ramping without impacting of the chalk/lime of BTWH construction and maintenance.

Beyond the horse itself there is also a cache of angle irons. Presumably not used or discarded at a point of refurbishment. Along the neck of the BTWH are also eight wooden steps pegged into the hillside that led from the field above turning and start to run parallel to the BTWH's back. The lower 4 steps were only uncovered after the initial survey under overgrowth. This demonstrates the encroachment of the hedgerow on the clear space around the BTWH. #

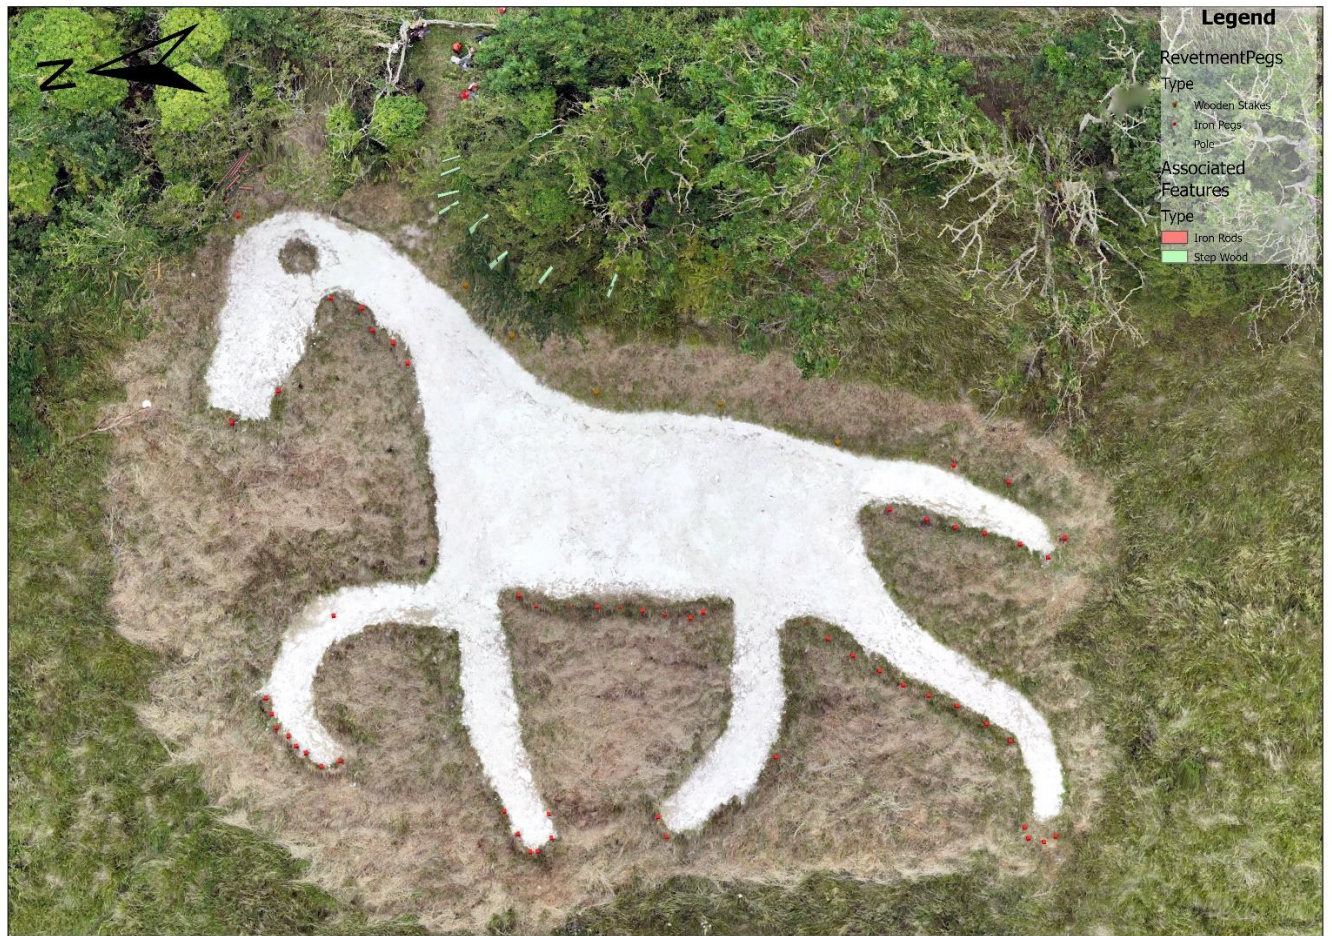
Figure 15 Perpendicular view of BTWH

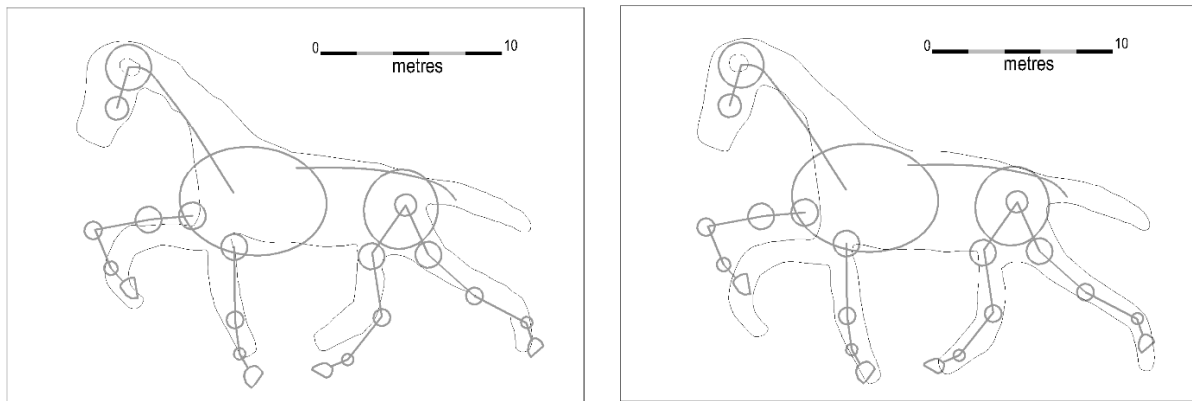
Comparing the rotation from an orthographic view (90°) and one tilted to be perpendicular to the hillside (118°) against an 'ideal' dimension of a horse. It is clear that the hillsides slope is the plane the horse was measured against. Nor is there any attempt at elongation of the body of height to account for forced perspective when viewed from the ground below the ridge.

Figure 16: Outline of the Broad Town White Horse with ideal version superimposed: Left an Orthographic view, Right viewed perpendicular to the Hillslope at 118°

Orthographic projection refers to the top-down flat projection allowing distances to be measured horizontally and vertically. Whereas perpendicular viewpoint views the BTWH from 90 degrees from the slope of the hill allowing ground distances to be calculated, and to test that hypothesis that the white horse was originally measured out this way

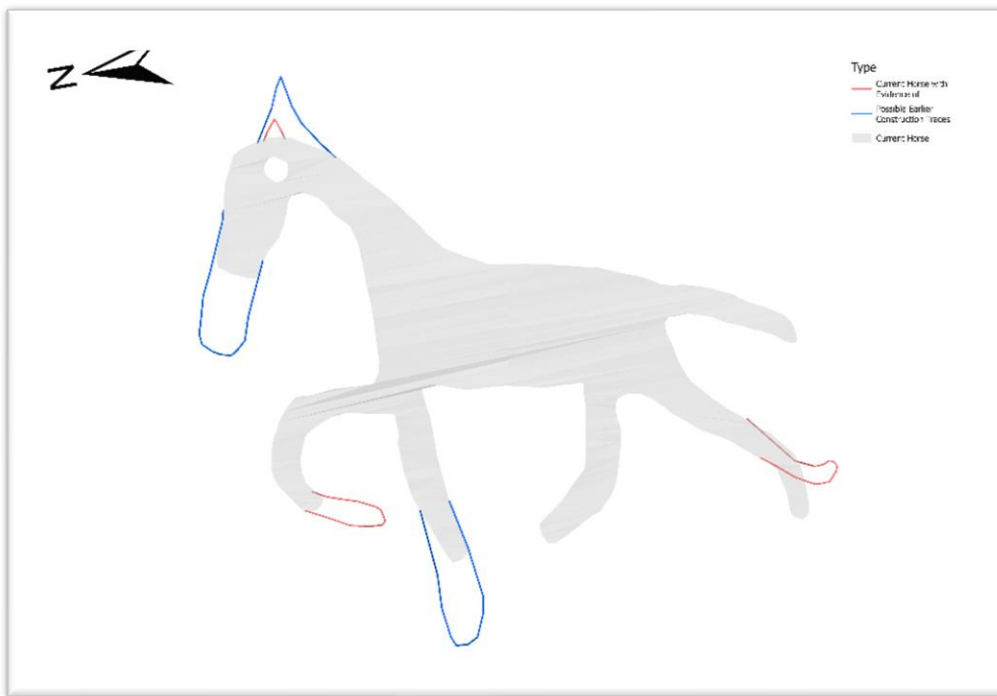
Figure 20: Interpretation of possible previous WhiteHorse constructions

The GNSS survey has evidence of either an elongated head or possible, and more in keeping with the scale of the BTWH, some element of survival of a truncated ramp, which hasn't been completely levelled out when the revetment was placed. There is also the appearance of further elongation of the front raised leg and a possible flick of the rear back leg creating more of a gallop rather than a *levade* standing stance (see figures 12-14 and figure 20).

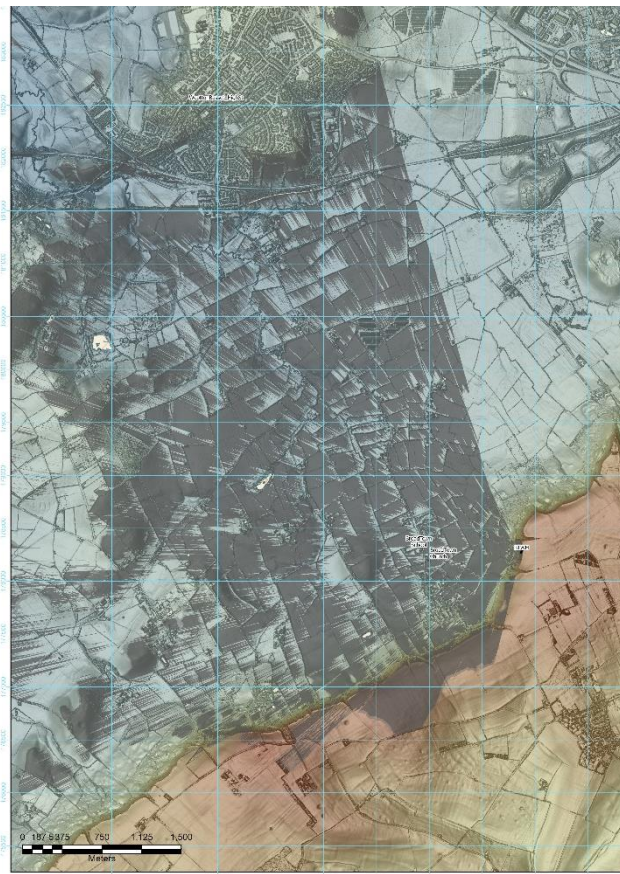
The viewshed analysis, based on the 2019 Digital Surface Model (DSM), indicates that the BTWH would have been widely visible, with sightlines extending from the west-southwest to the west-northwest, including Broad Town itself. In the 19th century, prior to 20th-century developments, it would likely have been visible from most of Royal Wootton Bassett.

Figure 21: 2019 DSM viewshed set a 1m and 1.6m above ground level

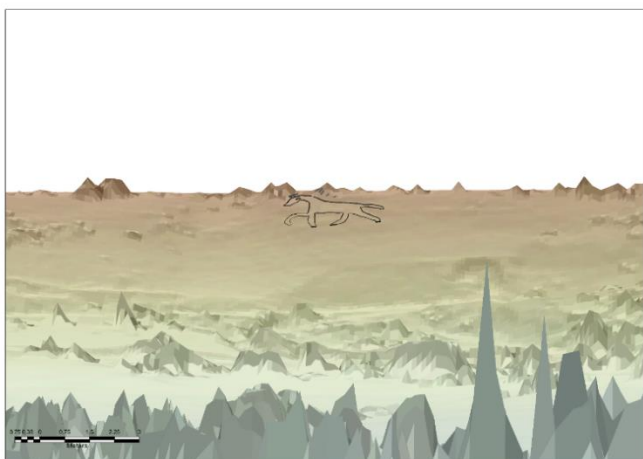
Figure 22: View of BTWH from Broad Town Church

There is little difference in view from between the view from the church or the school, but the school has the least difference in aspect meaning it has a slightly superior view of the Horse, making it the most likely point of the intended viewpoint of the BTWH.

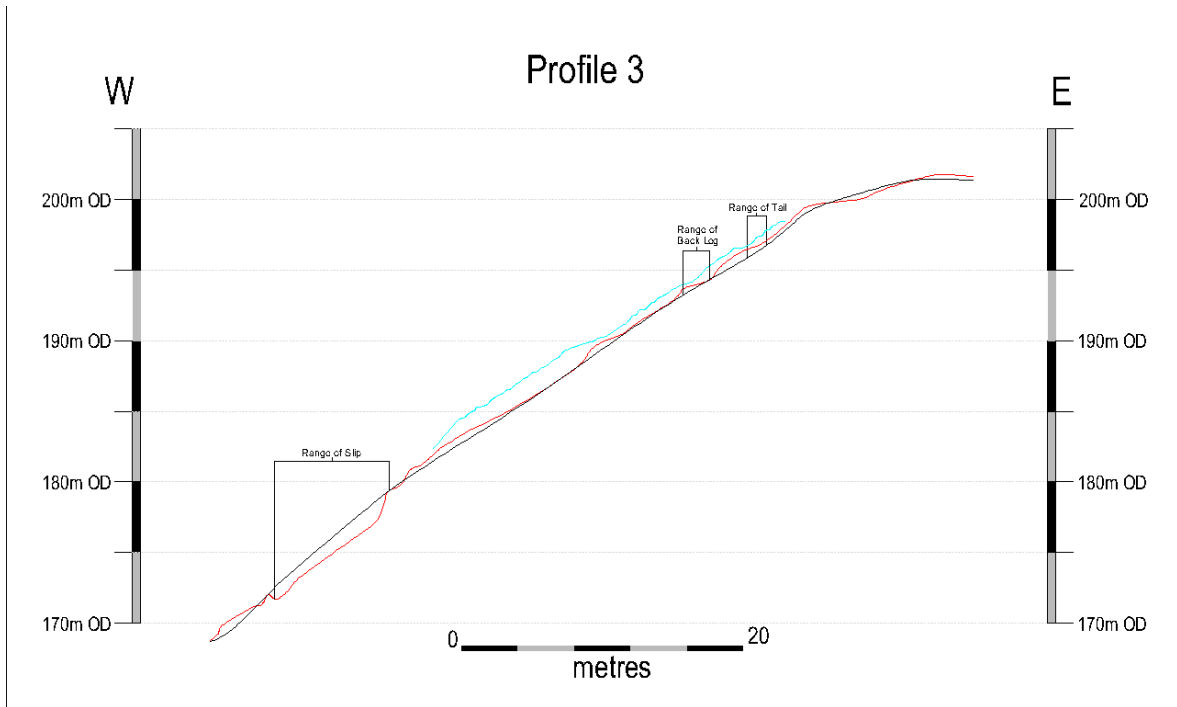
Figure 30: Profile 3, crossing tail and back leg and area of collapse. (red line photogrammetry, cyan line GNSS survey, grey line 2019 LiDAR)

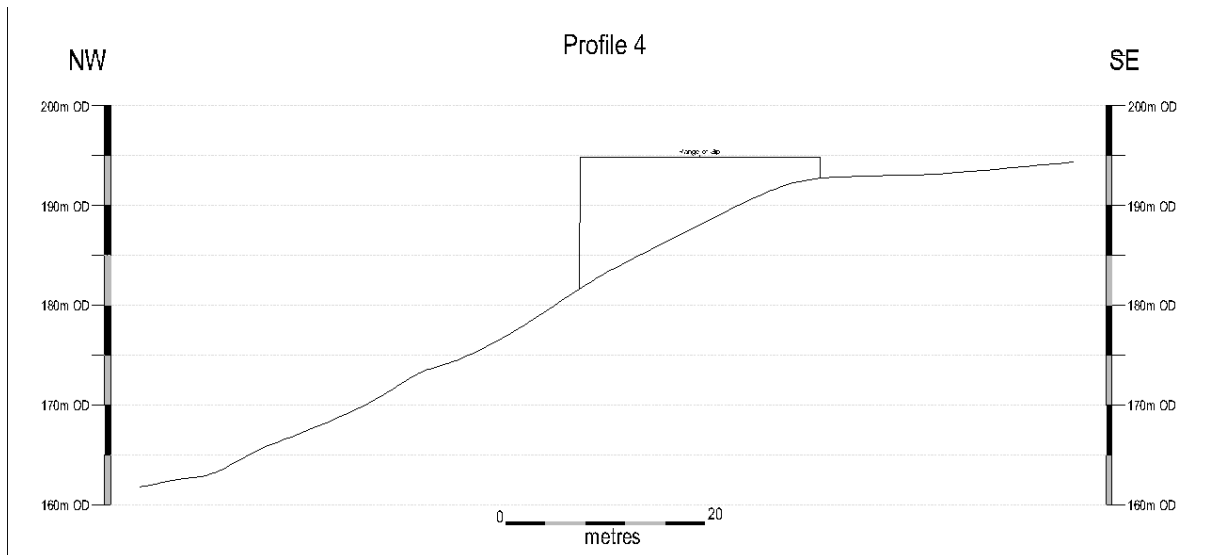
Figure 31: Profile 4, crossing area of collapse 1 to the south of BTWH. (2019 LiDAR only)

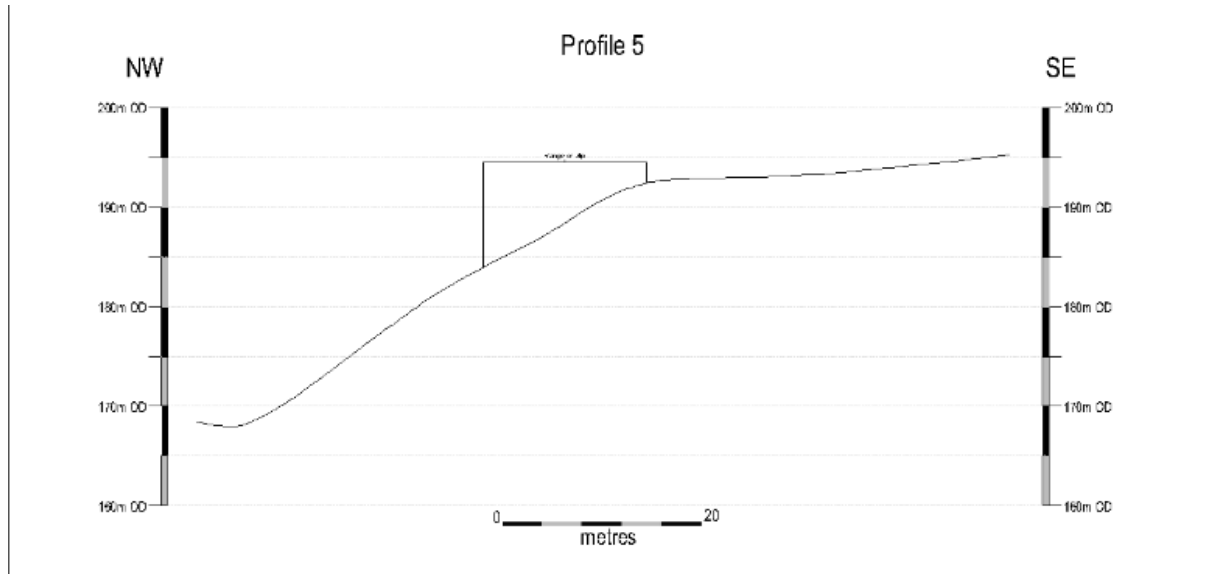
Figure 32: Profile 5, crossing area of collapse 2 to the south of BTWH. (2019 LiDAR only)

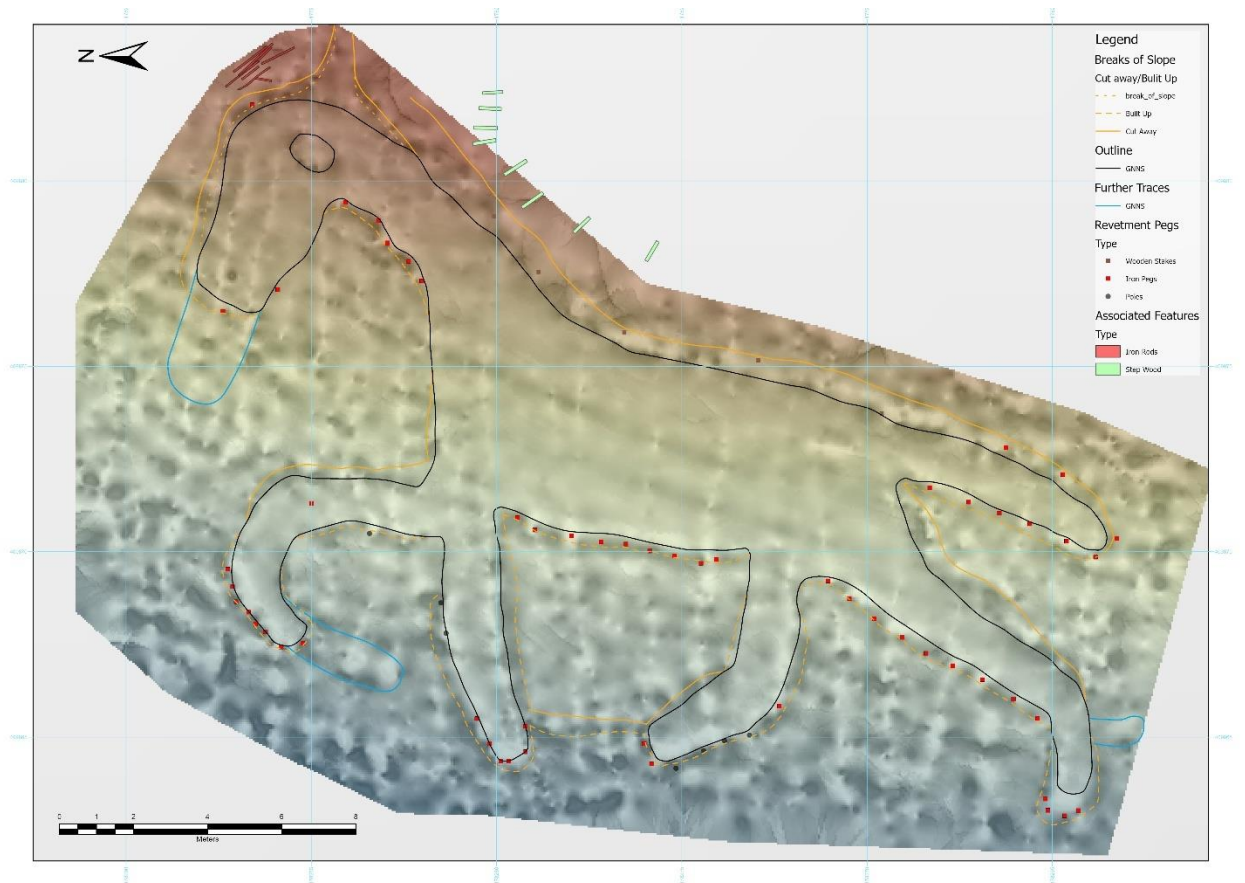
Figure 12: Stacked Model with interpretation from GNSS Topographic Survey (left) from UAV (right)

From the analyses generated from the topographic survey, of both the UAV photogrammetry and the GNSS survey, the results are very similar. In regards to the BTWH outline, the cutting into the hillside and the areas build up there is only minor variation between the two variations of recording.

The photogrammetry data supports the possible ramp at the end of the head and the elongation to the raised front leg. There are also indications of continuation/truncated ramp at the end of the inside front leg. The rear leg doesn't seem to have the extension, possibly due to the longer grass in this area that the GNSS data could penetrate that the photogrammetry couldn't. Finally, there is a greater depression above the head than the expected slope indicating a possible cut for a previous ear.
