Landslips on or near Broad Town Escarpment

REPORT FOR BROAD TOWN WHITE HORSE: HERITAGE
PROTECTION & SUSTAINABILITY THROUGH
COMMUNITY ACTION

Derek Greer and BTWH Restoration Group 23/10/2025

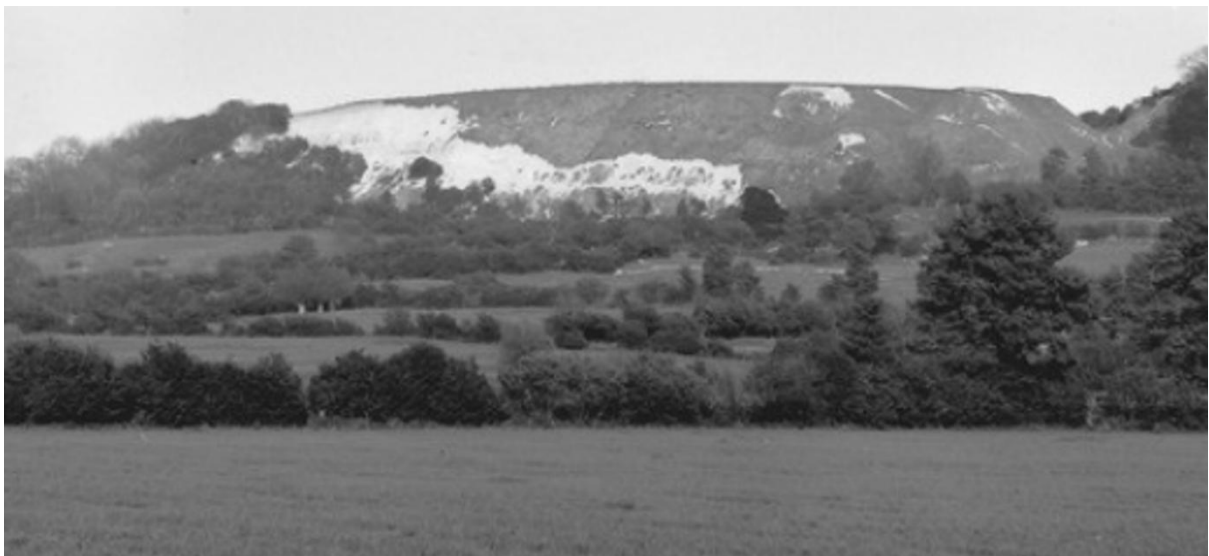
Source: British Geological Survey. P202622. <http://geoscenic.bgs.ac.uk/asset-bank/action/viewAsset?id=17142&index=6537&total=116287&view=viewSearchItem#>

P number:	P202622
Old photograph number:	A02674
Caption:	Landslip above Little Town, Broad Town. Looking E.
Description:	Landslip above Little Town, Broad Town. Looking E. Landslip at Little Town. Flat land on Kimmeridge Clay in foreground; rising fields with timbered hedges mostly on the Selbornian Beds; escarpment of Lower Chalk in the background. The quarry-like scar in the escarpment is due to a landslip which occurred in 1870.
Date taken:	01/05/1924
Photographer:	Rhodes, J.
Copyright statement:	Crown
X longitude/easting:	409500
Y latitude/northing:	178500
Coordinate reference system, EPSG code:	27700 (OSGB 1836 / British National Grid)
Orientation:	Landscape

This photograph of the landslip was taken in May 1924 by J Rhodes. Published on the [British Geological Survey](#) website and reproduced below.

The formal BGS record states the landslip date as 1870. Assuming the local newspaper is correct (see above) then the BGS date should be corrected to 1877.

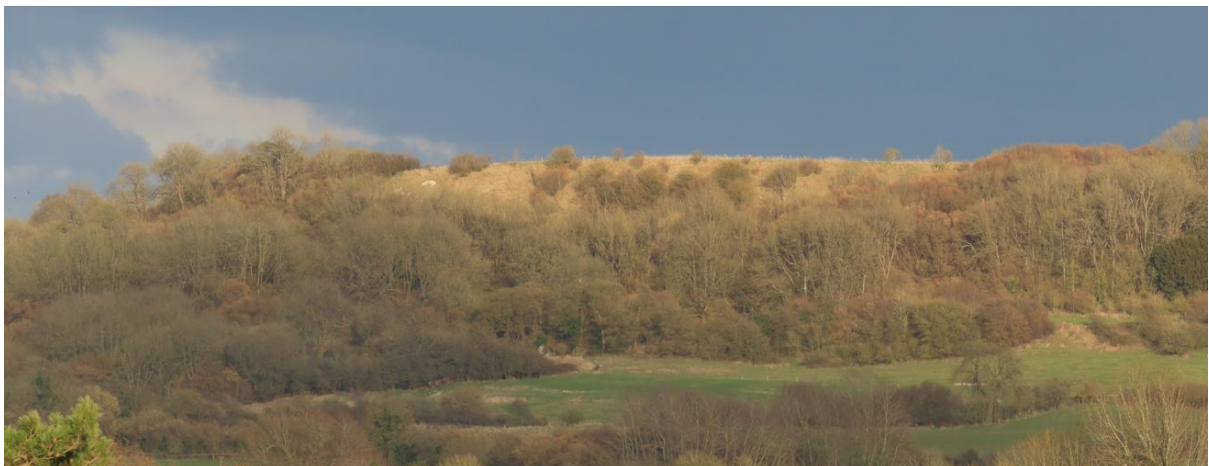
Same escarpment slope in 2025. Photograph taken by D. Greer.

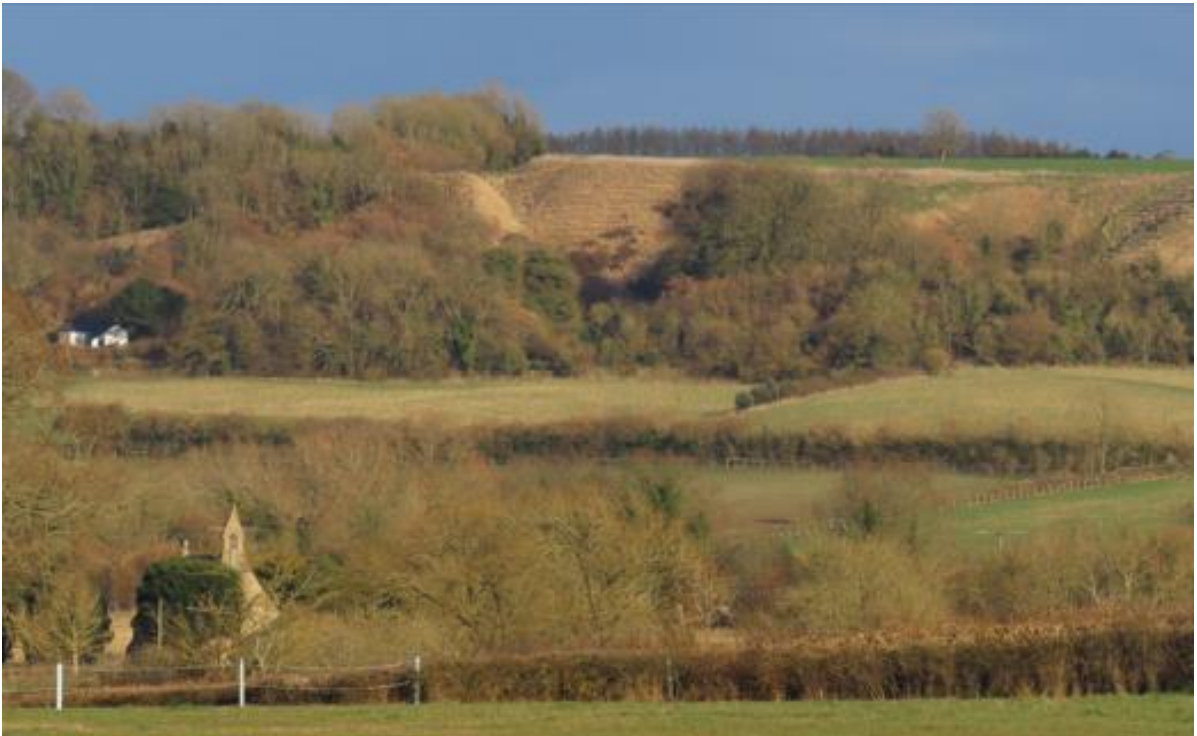
This is a photograph of the same escarpment slope in 2025 (Source D. Greer). The slip is at bottom of current dry gully just to south-west (right in photo) of the edge of Snowhill Cottage's (white building) garden boundary.

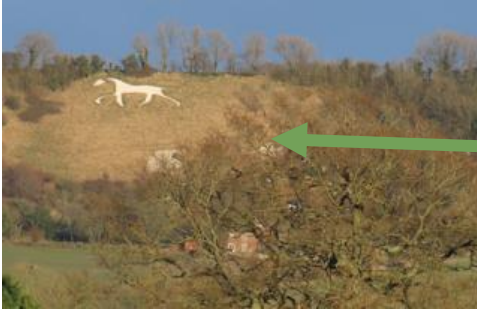
The slightly older landslip in the proximity of the horse occurred in Dec 2013. This is below the horse on the steeper part of the slope and is close to but 10-20m south-west of the most recent Sep 2024 slip. It is partially hidden behind trees in this photograph.

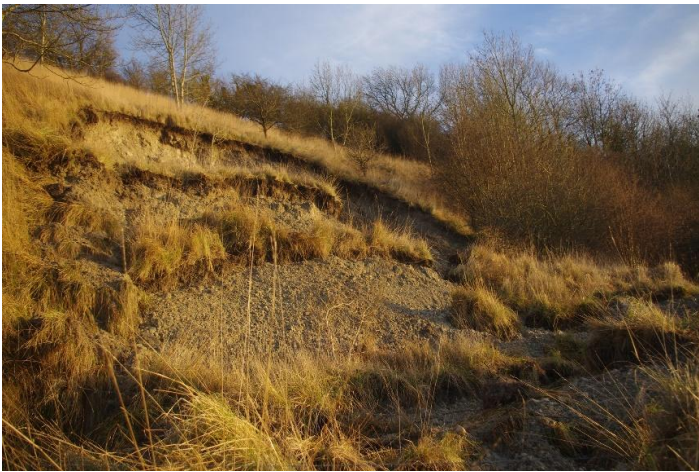
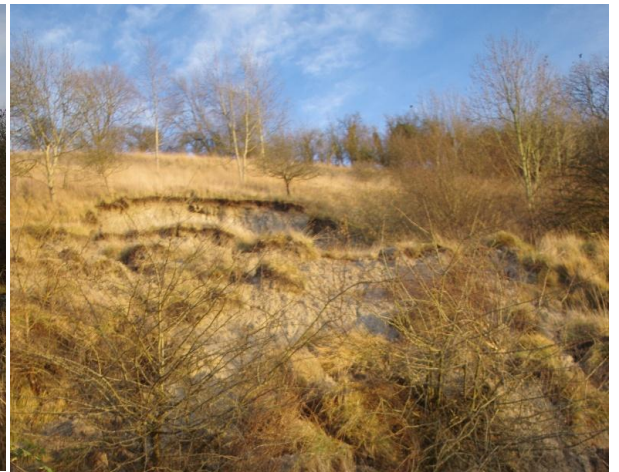
These photos below were taken on 31/12/2013 (Source Andrew Law):

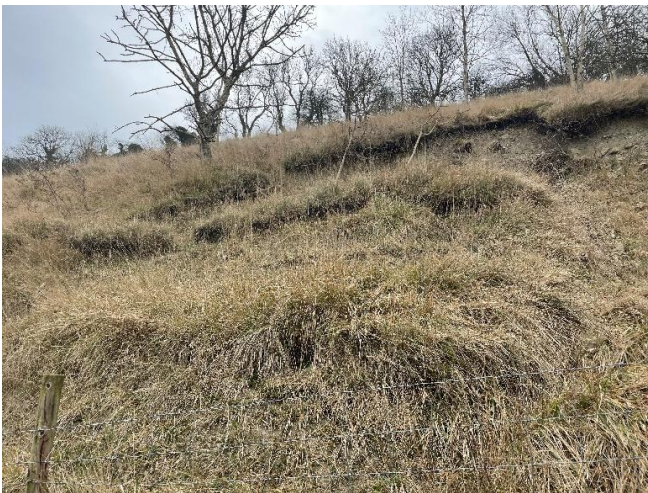
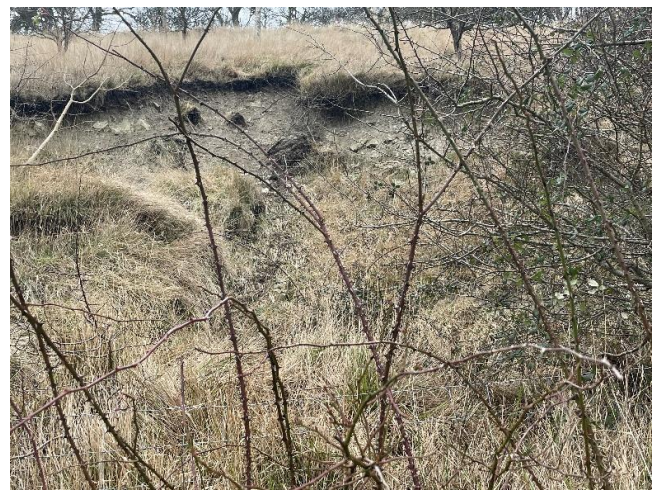
Photos of the same landslip taken in 2025 are below (Source Derek Greer).

There has not been much change in the size of the landslip between 2013 to 2025.

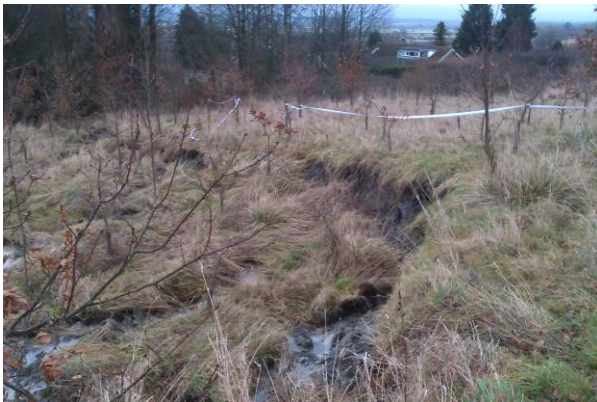
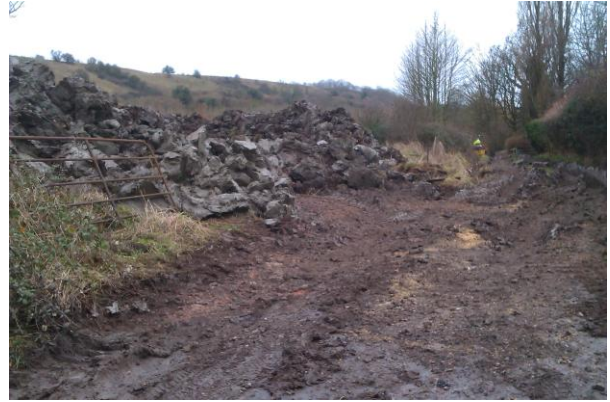
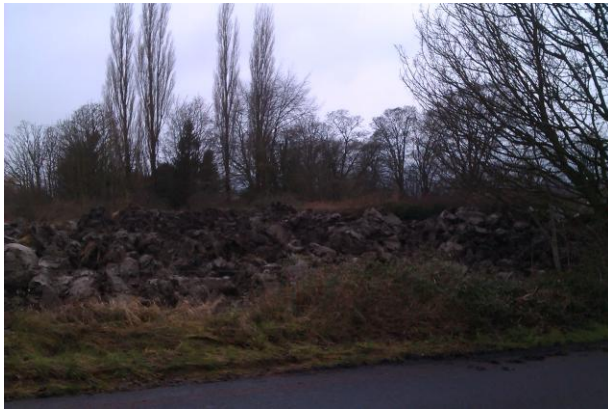
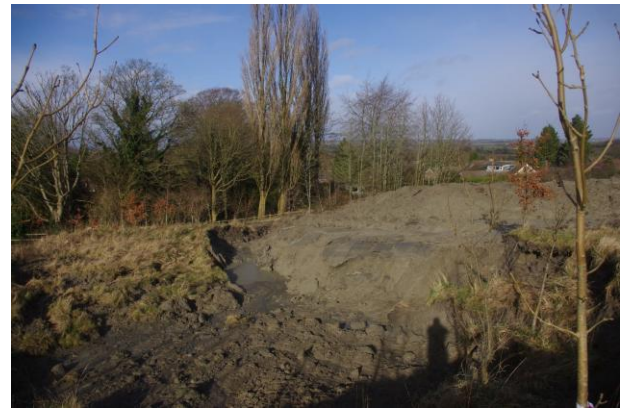
This landslide occurred on the field to the west of Broad Town Road as it descends the hill into Broad Town. This is immediately above the first houses. It occurred at the same time or shortly after the 2013 December land slip below the white horse. Our record is via photographs taken in January 2014 of the landslip and then in February 2014 during the clear up which was undertaken.

It is “local knowledge” that the field had been used as a deposit/dump for clay dug out during the construction of the dairy being dumped on that field some years previously. This clay was then undermined by springs and winter rain and it was the clay which slipped not the chalk bedrock. The frozen water can be seen in the photos.

The field had in 2014 been recently planted with young trees (see photograph at top left) and this planting is now relatively mature (2025) forming a small copse with permitted access for visitors.

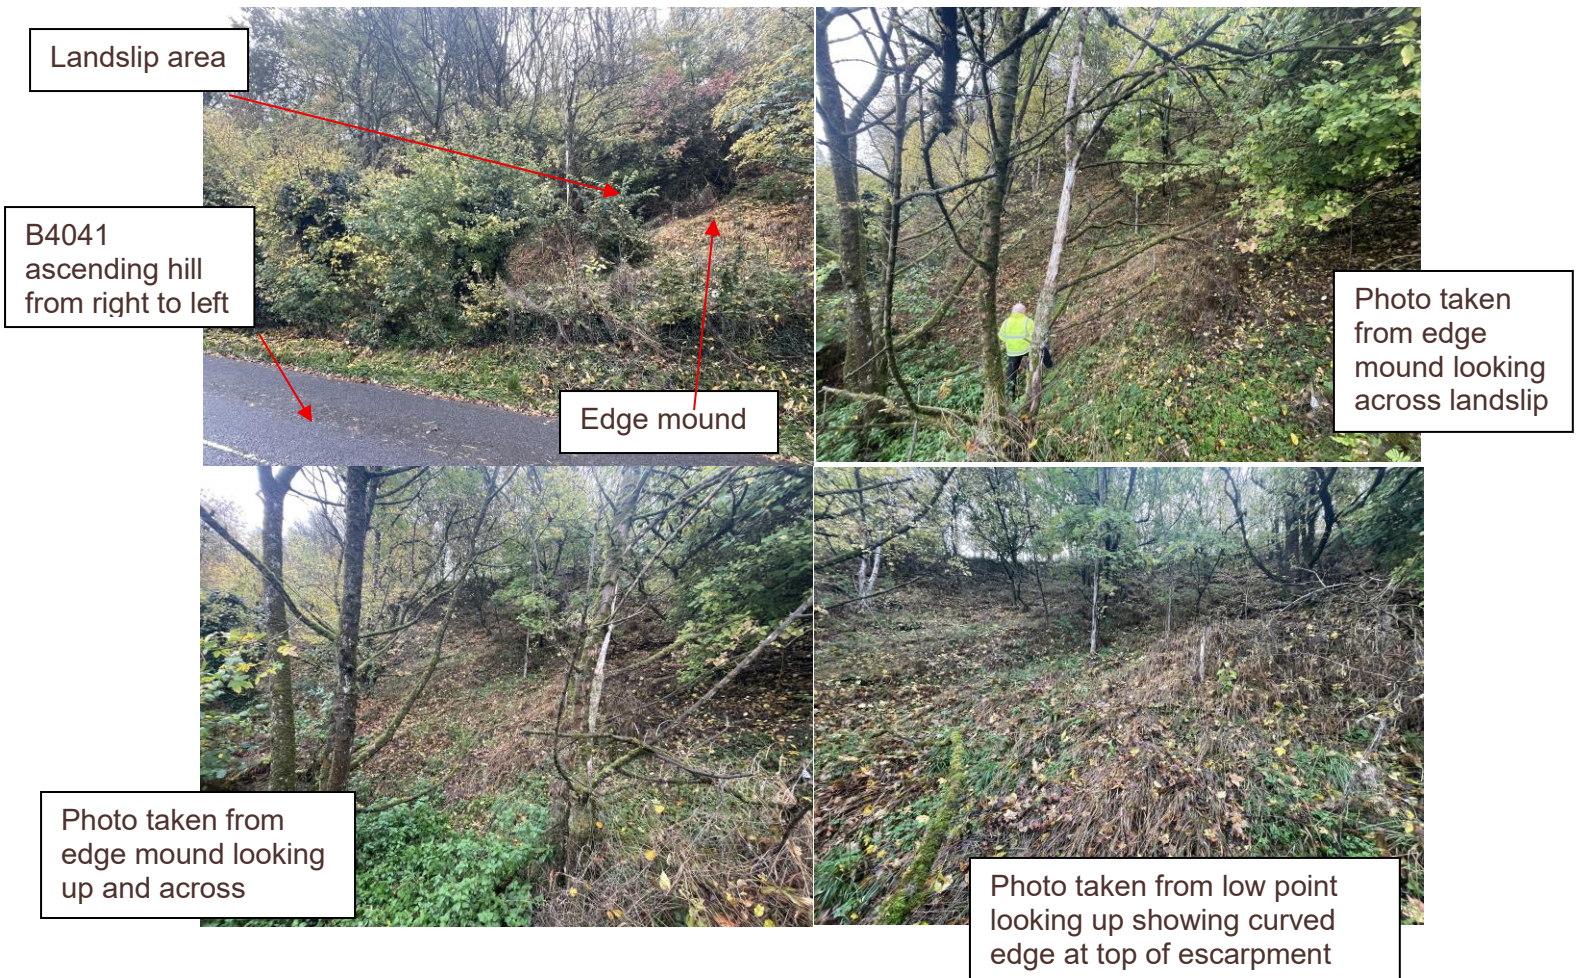
The landslip apparently covered the road and spilling across and down the lower slope. A slight rise in the bank can still be determined at the point the slip exited the far side of the road, but the main evidence is the missing part of the escarpment.

The site of the landslip is able to be visited. The escarpment immediately above and at the side of the road shows evidence of a large semi-circular gouge having been removed from the otherwise flat face of the steep slope. This is now filled with vegetation. Photographs below (source Derek Greer and David Button 2025) attempt to give some idea of the scale and shape in 2025.

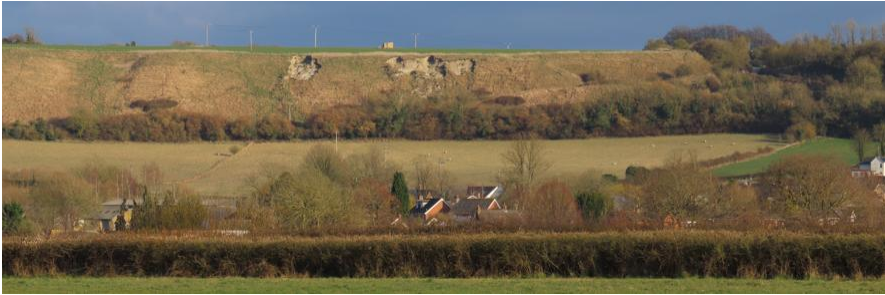
A set of 2 large landslips occurred on the scarp slope south-west of the horse location closer to where the Broad Town to Broad Hinton road climbs the hill. They are also near the block house on the plateau which is a bore hole for water extraction. They are several 100m south-west of the horse on the other side of a gully.

They start at the top of the slope and extend part way down the slope. They were almost side by side.

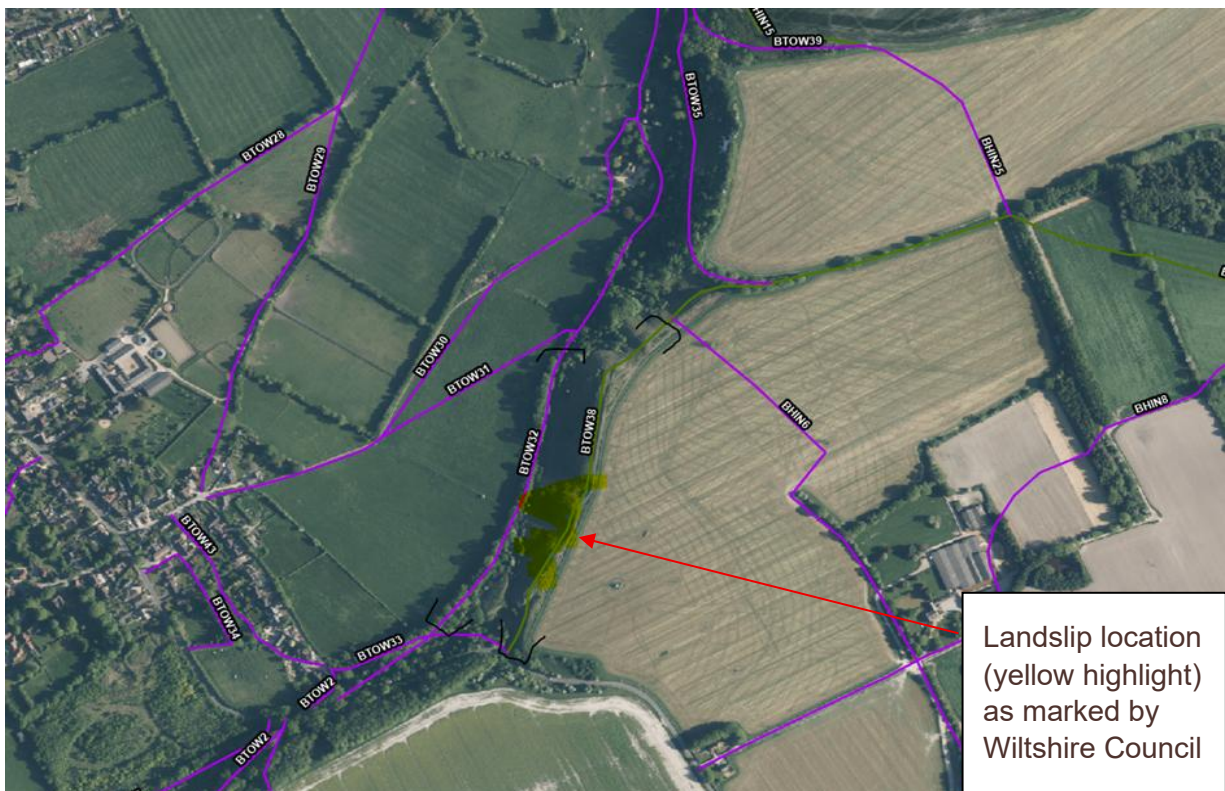
(Source: Wiltshire Council 2023)

They occurred during a period of very heavy prolonged rain in November/December 2023 following a very wet autumn. Local residents note that the double landslip was very noticeable in early December. Online records ([Right of Way closures due to landslips – Broad Town Parish Council](#)) show that Wiltshire Council closed the top and bottom paths along the escarpment on 3 November 2023 due to the landslips.

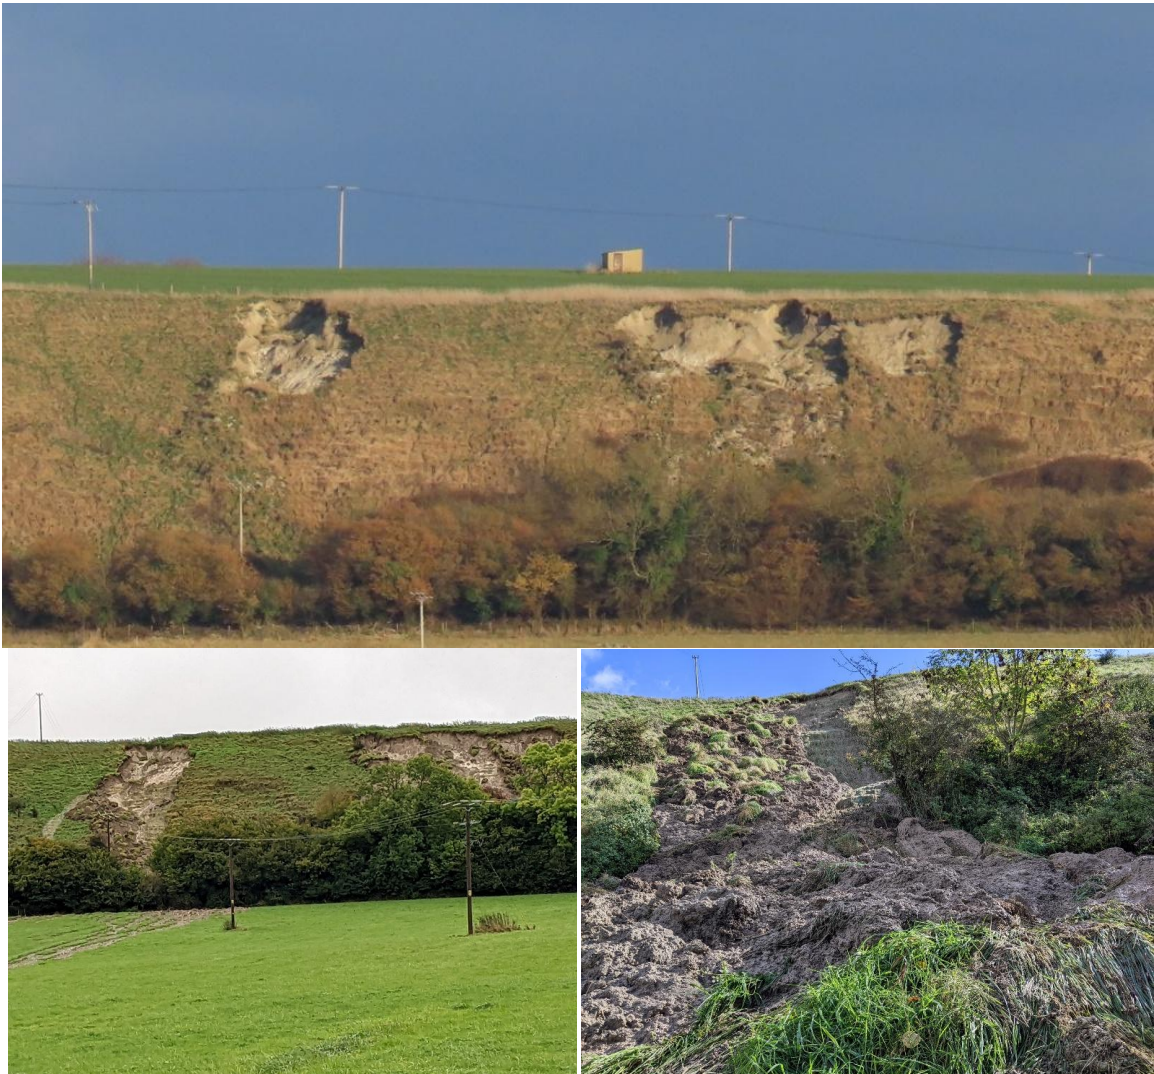
The following assessment was made by Donald Horne during his GPS and drone survey in 2025 as to the likely reason for the landslip occurring at this location: “It is the interface of the differing underlying geology along with the slope that increases potential of slip. The ... landslips to the south [of the horse] ... exist on two meeting Geologies but rather than the Upper Greensand formation the slips are occurring just under the interface between the Zig Zag chalk formation above the West Melbury Chalk Formation (*BGS Geological Viewer* accessed July25) and sits on a slope of approx. 33°.”

Photographs below source: Derek Greer 2025, Andrew Law 2024.

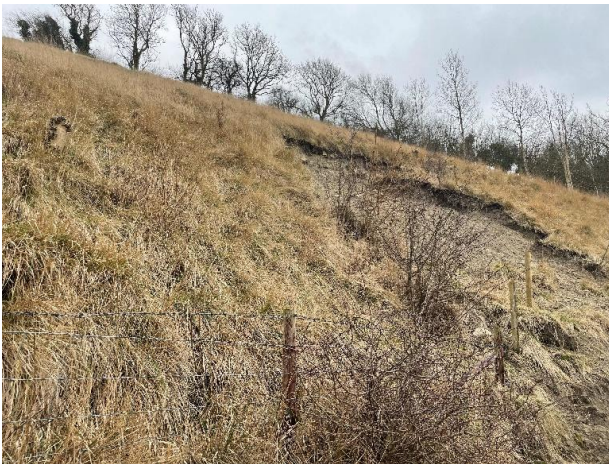
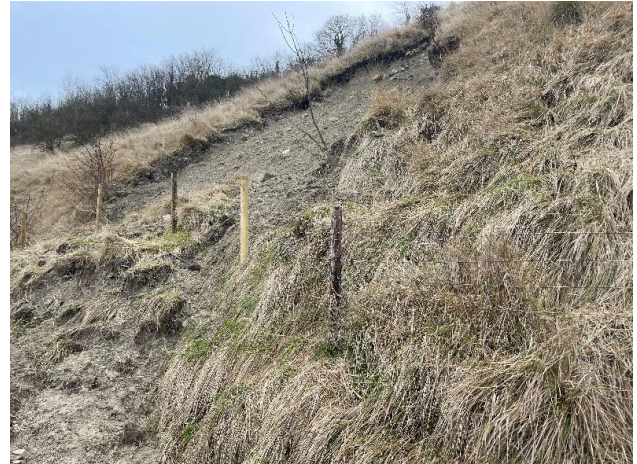
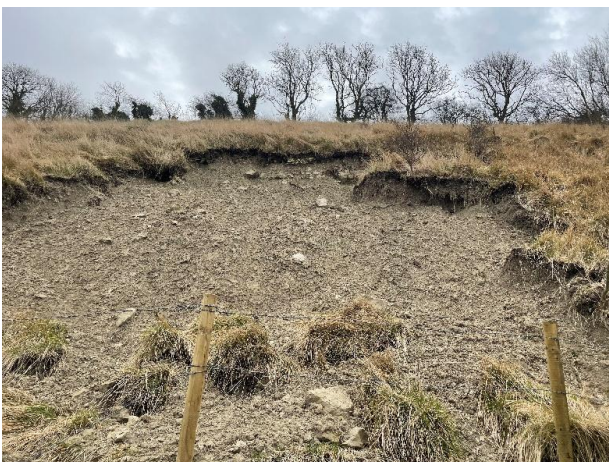
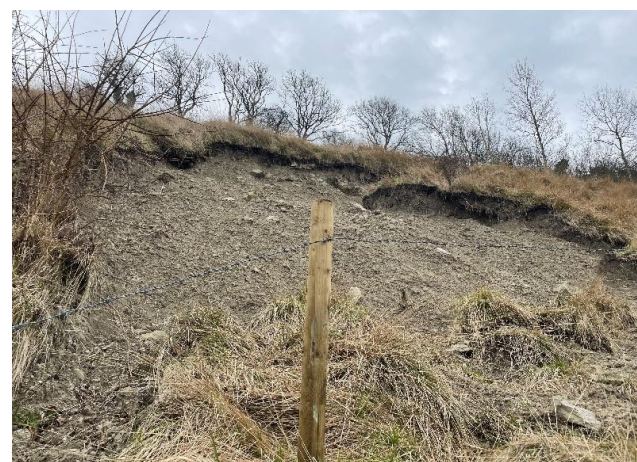
This landslip below and marginally to west of the White Horse occurred on 25/26 September 2024 after some heavy rain in preceding days. The landslip is towards the foot of the slope on the steepest angle, directly above the fence at the side of the white horse trail path below the slope. The landslip actually flowed over the path, blocking it and covered the white horse sign. The overflow has subsequently been “flattened” to some extent enabling the path to go over the clay/mud of the bottom of the slip. The fence posts were reinstated after the slip. From the path the horse itself cannot be seen due to the change of slope above the landslip and below the horse. The top of landslip has gradually broadened sideways over 6 months Sep 24 to Mar 25.

The following assessment was made by Donald Horne during his GPS and drone survey in 2025 as to the likely reason for the landslip occurring at this location: “The slope that

collapsed under the BTWH occurred at about 46° whereas the BTWH sits on the more secure slope of 28-34°. With the natural underlying slope, presumably similar to the slope adjacent to the BTWH which is around 35° with a maximum of 44°. The reason for collapse is most likely not solely due the incline as the point of collapse is on the interface between the West Melbury Chalk Formation and the Upper Greensands formation (*BGS Geological Viewer* accessed July 25). It is the interface of the differing underlying geology along with the slope that increases potential of slip.”

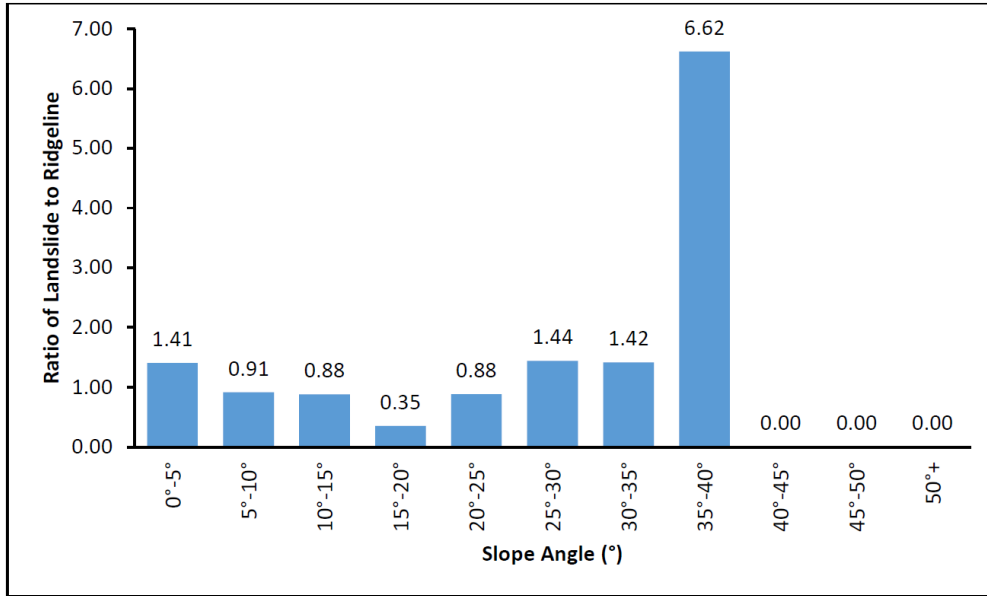
Figure 20: Slope angle bar graph for landslides to ridgeline ratio

Statistical analysis has shown that the following four classes of slope angle experience a disproportionate number of landslides:

Landslide susceptibility is found to increase as the slope increases from 25° to 40° ; this compliments the work reported in the literature where a 30° to 35° maximum stable slope angle has been proposed for natural chalk escarpments. However, the slope angle class of 0° to 5° is an anomalous result which does not fit this trend and is unexpected based on literature. This result is likely caused by a systematic error whereby some landslides have been plotted in the landslide database at the base which would have an uncharacteristically small slope angle compared to the rest of the slide. The Figure 20 below plots the ratio of ridge slope to landslide. A number greater than one indicates more susceptibility to landslide. As can be seen slopes $>35^\circ$ are highly likely to have landslides.

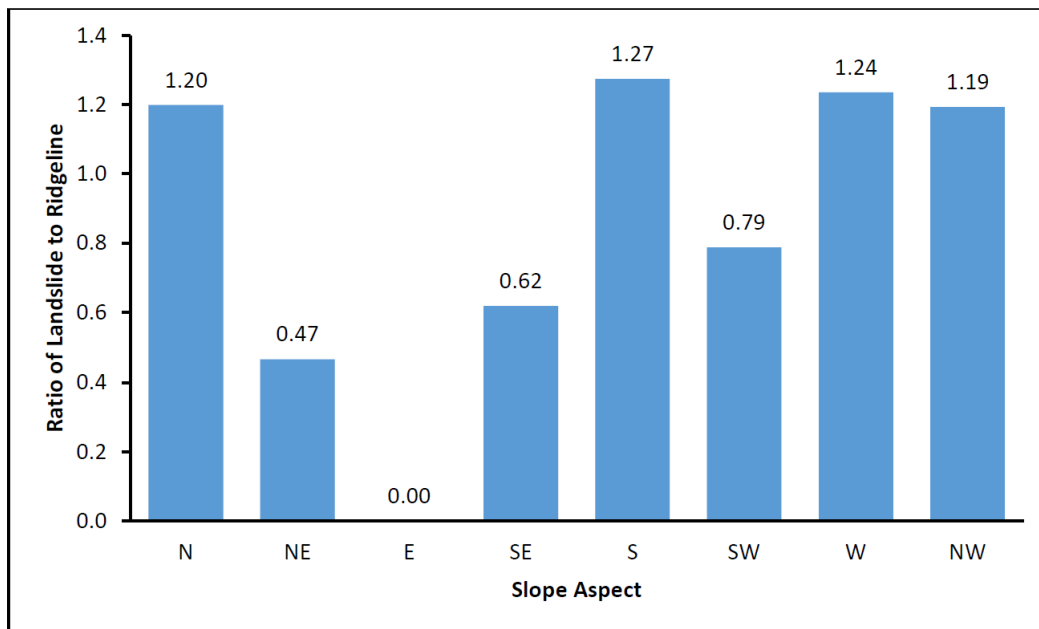
Figure 27: Slope aspect bar graph for landslides to ridgeline ratio

The slope aspect (ie direction the slope faces) surprisingly has some impact as slopes facing in the West – North-west – North direction all have a ratio of occurring greater than one. There are suggestions in the literature that this may be due to less direct sunlight on those slopes and hence less drying out of the soils after saturation. Whilst slopes facing south also seem to exhibit higher landslips, this is not born out by adjacent facings and so no conclusion can be drawn on southern facings.
